Geotechnical Scoping Report

Phase I-A/B Corridor Study

I-40 Arizona State Line to Atrisco Vista Boulevard Interchange

May 2, 2024

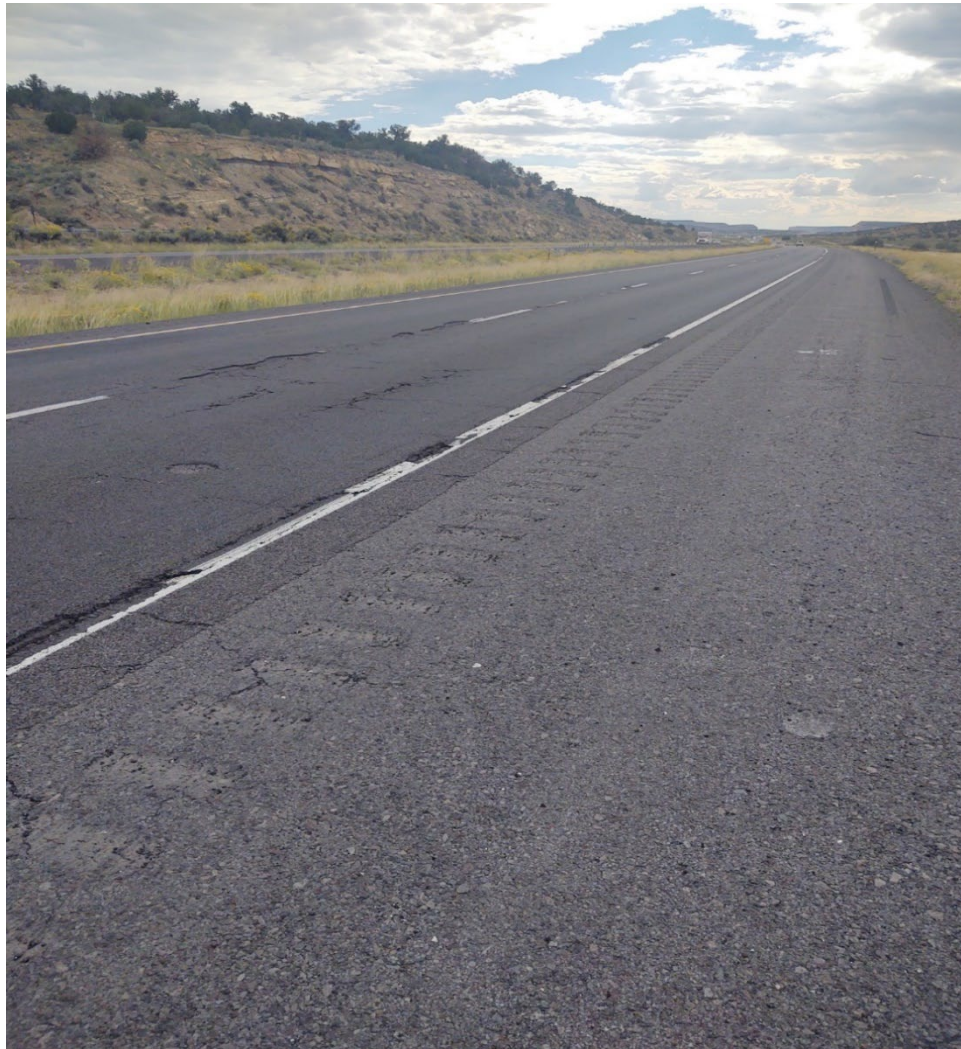
Photo 1: MP 10 - Looking West at WB Lane of I-40

Moderate severity lifting/stripping of OGFC/overlay. Low to moderate severity longitudinal, block, and transverse cracking. Low severity weathering and oxidation along shoulder

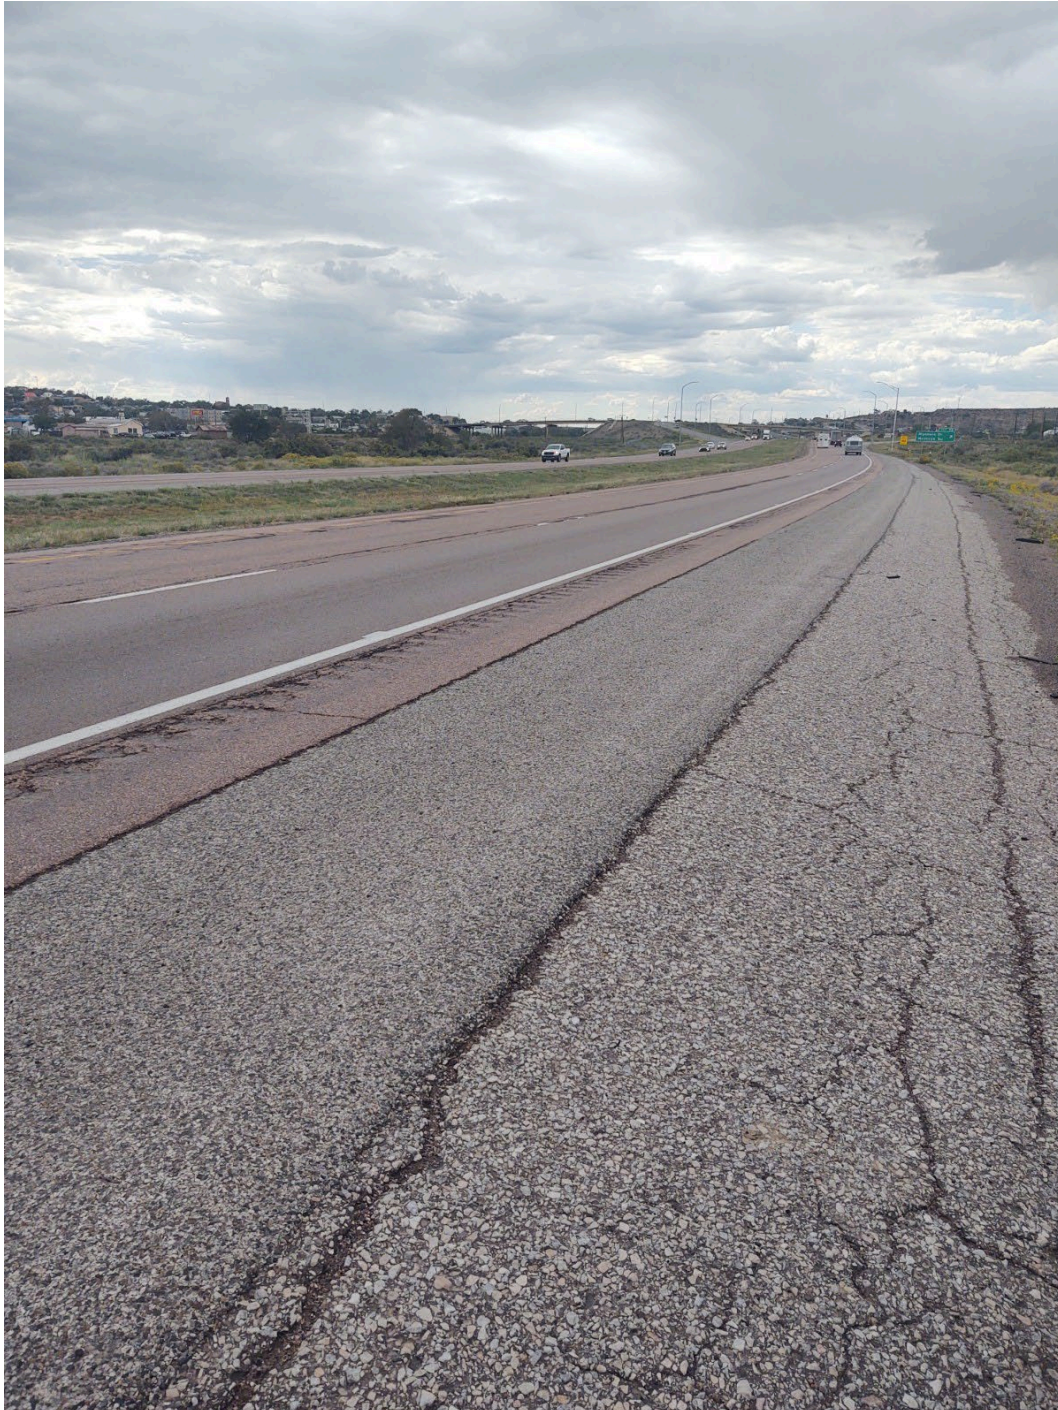
Photo 2: MP 23 - Looking SW along I-40

Low to moderate severity lifting/stripping of OGFC/overlay. Low to moderate severity longitudinal, block, and transverse cracking. Low to moderate severity transverse cracking, longitudinal cracking, weathering, raveling, and oxidation along shoulder

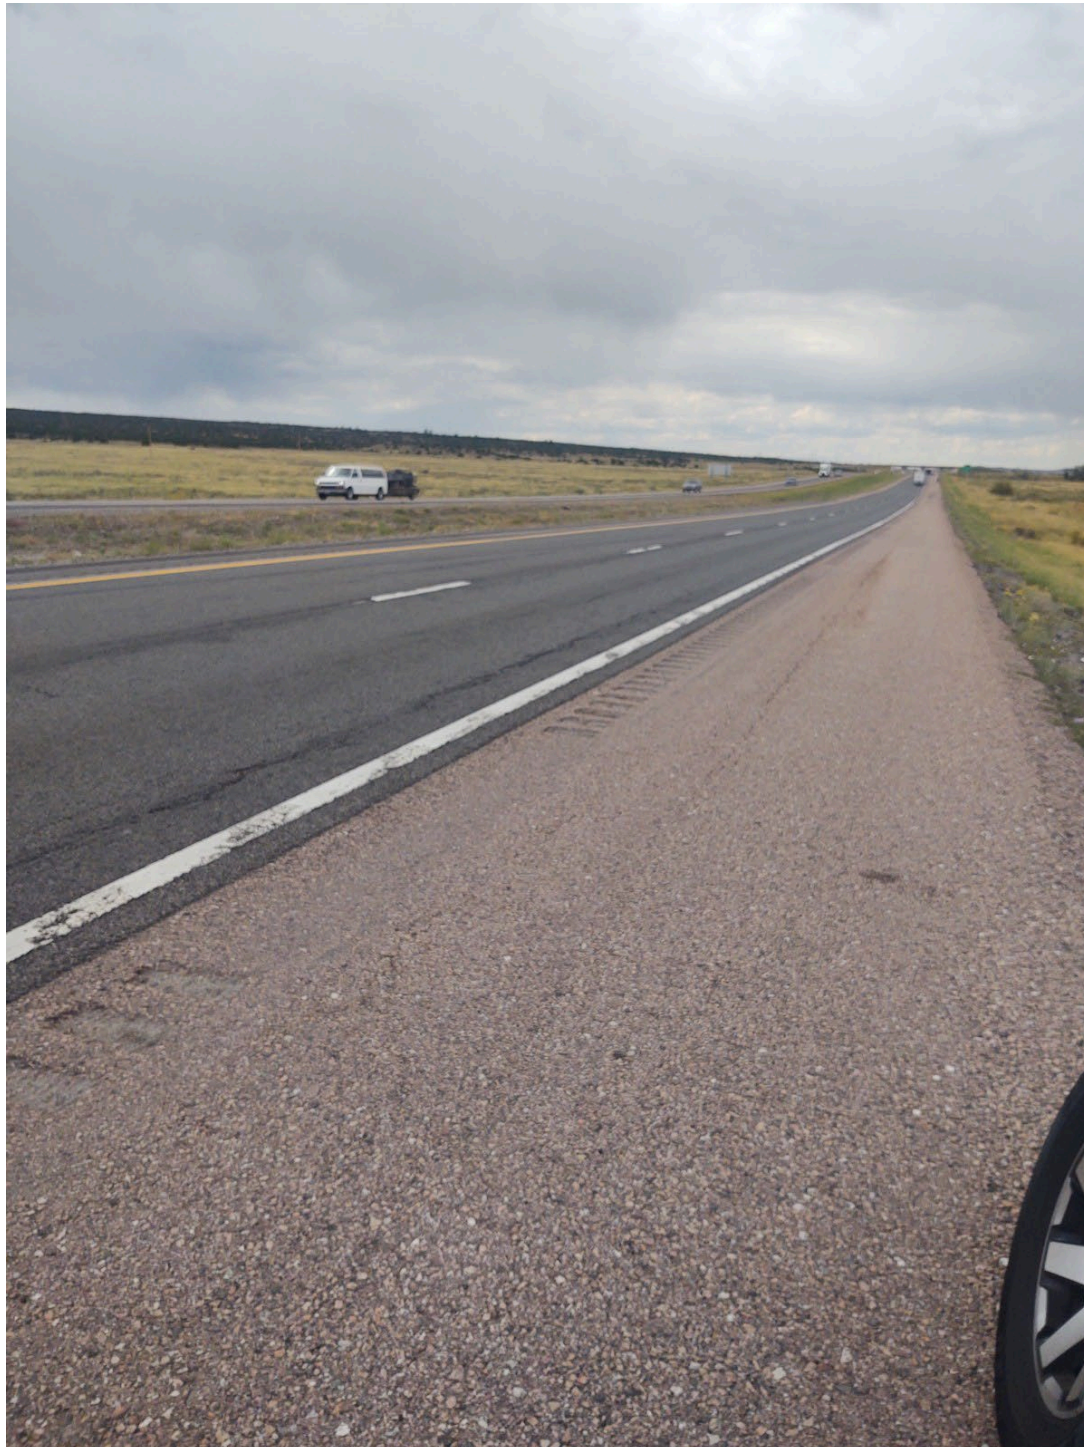
Photo 3: MP 38 - Looking SW along I-40

Recent OGFC/overlay. Low severity longitudinal cracking. Low to moderate severity weathering and oxidation along shoulder

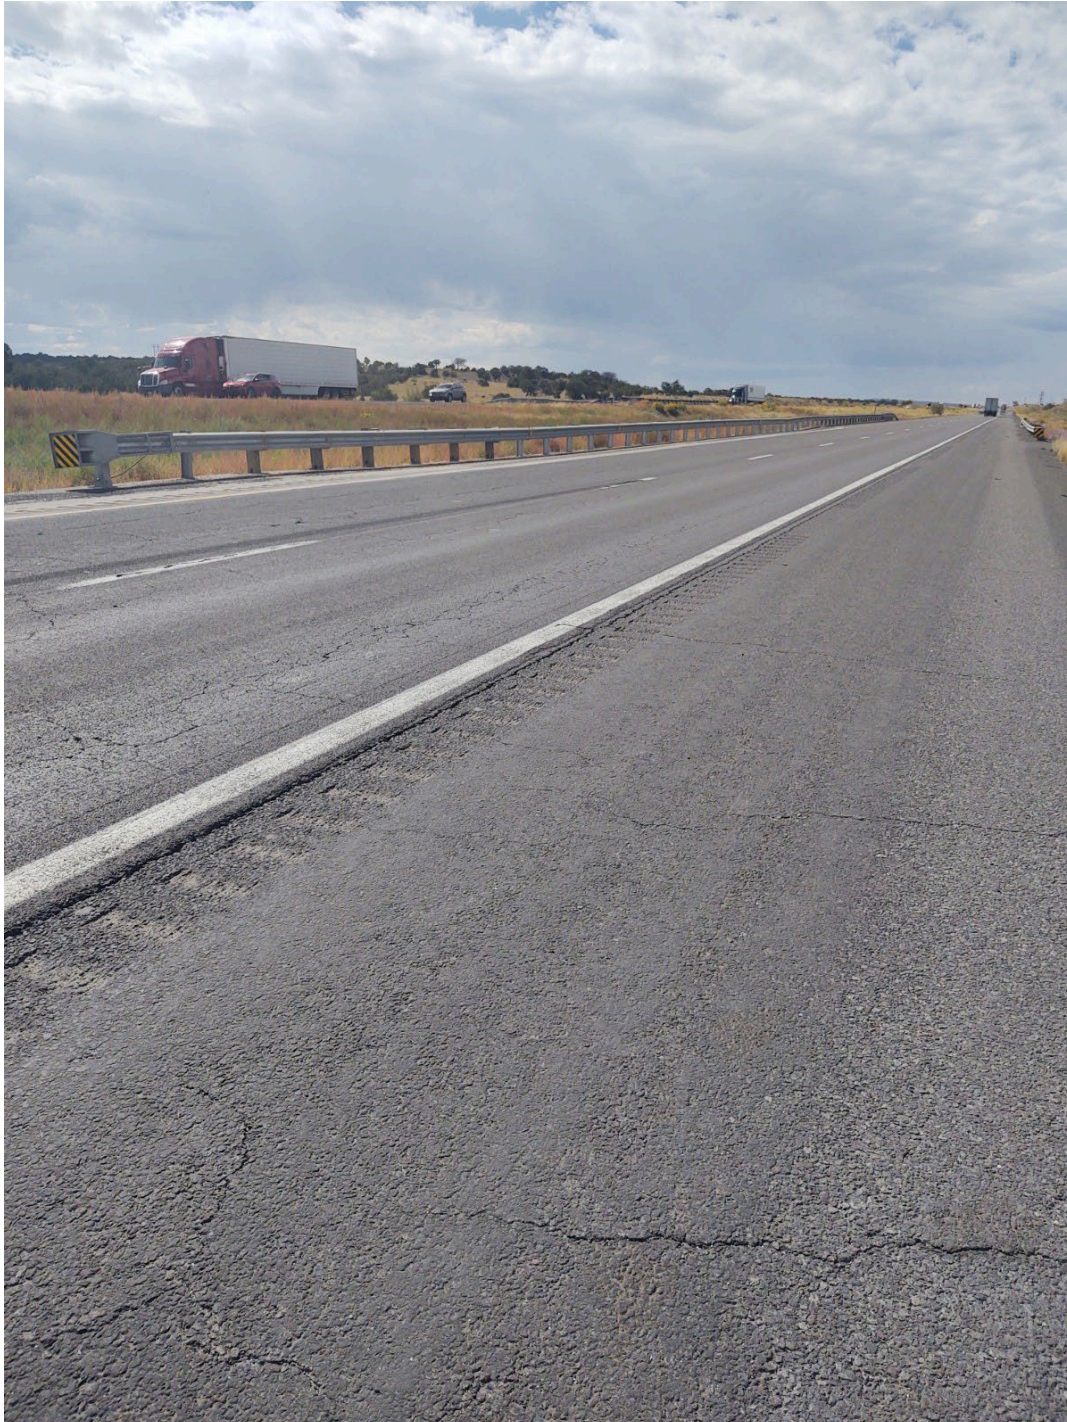
Photo 4: MP 58 - Looking SW along I-40

Low severity lifting/stripping of OGFC/overlay. Low to moderate severity longitudinal, block, and transverse cracking. Low to moderate severity transverse cracking, weathering, raveling, and oxidation along shoulder

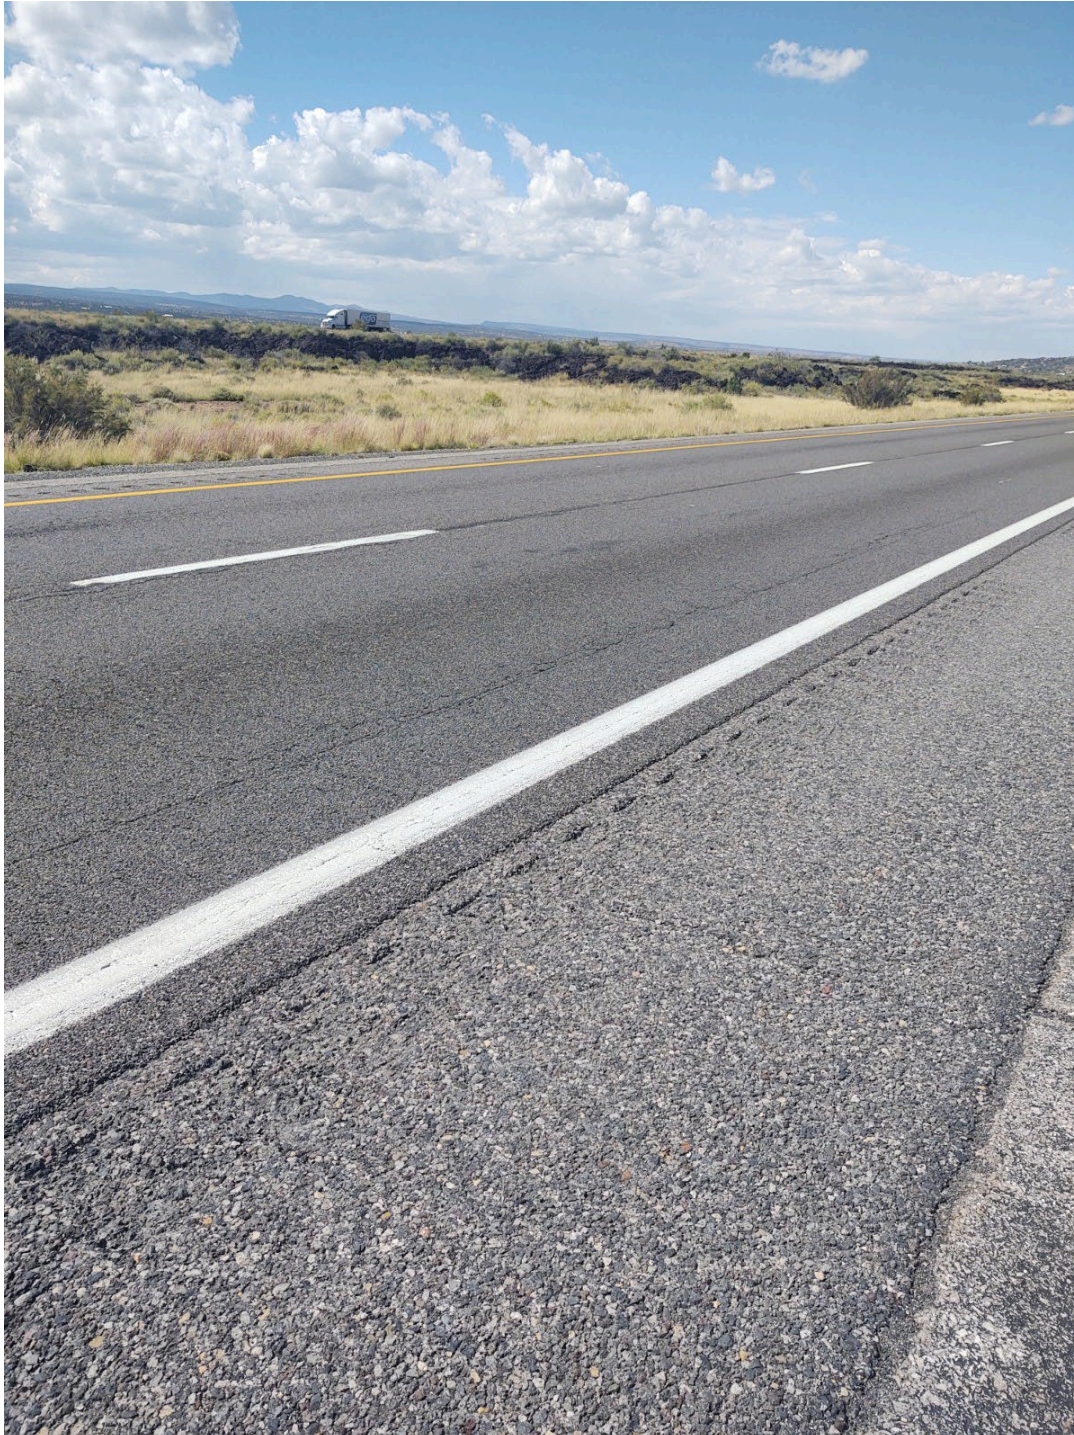
Photo 5: MP 84 - Looking W along I-40

Low severity lifting/stripping of OGFC/overlay. Low severity longitudinal and transverse cracking. Low to moderate severity weathering, raveling, and oxidation along shoulder

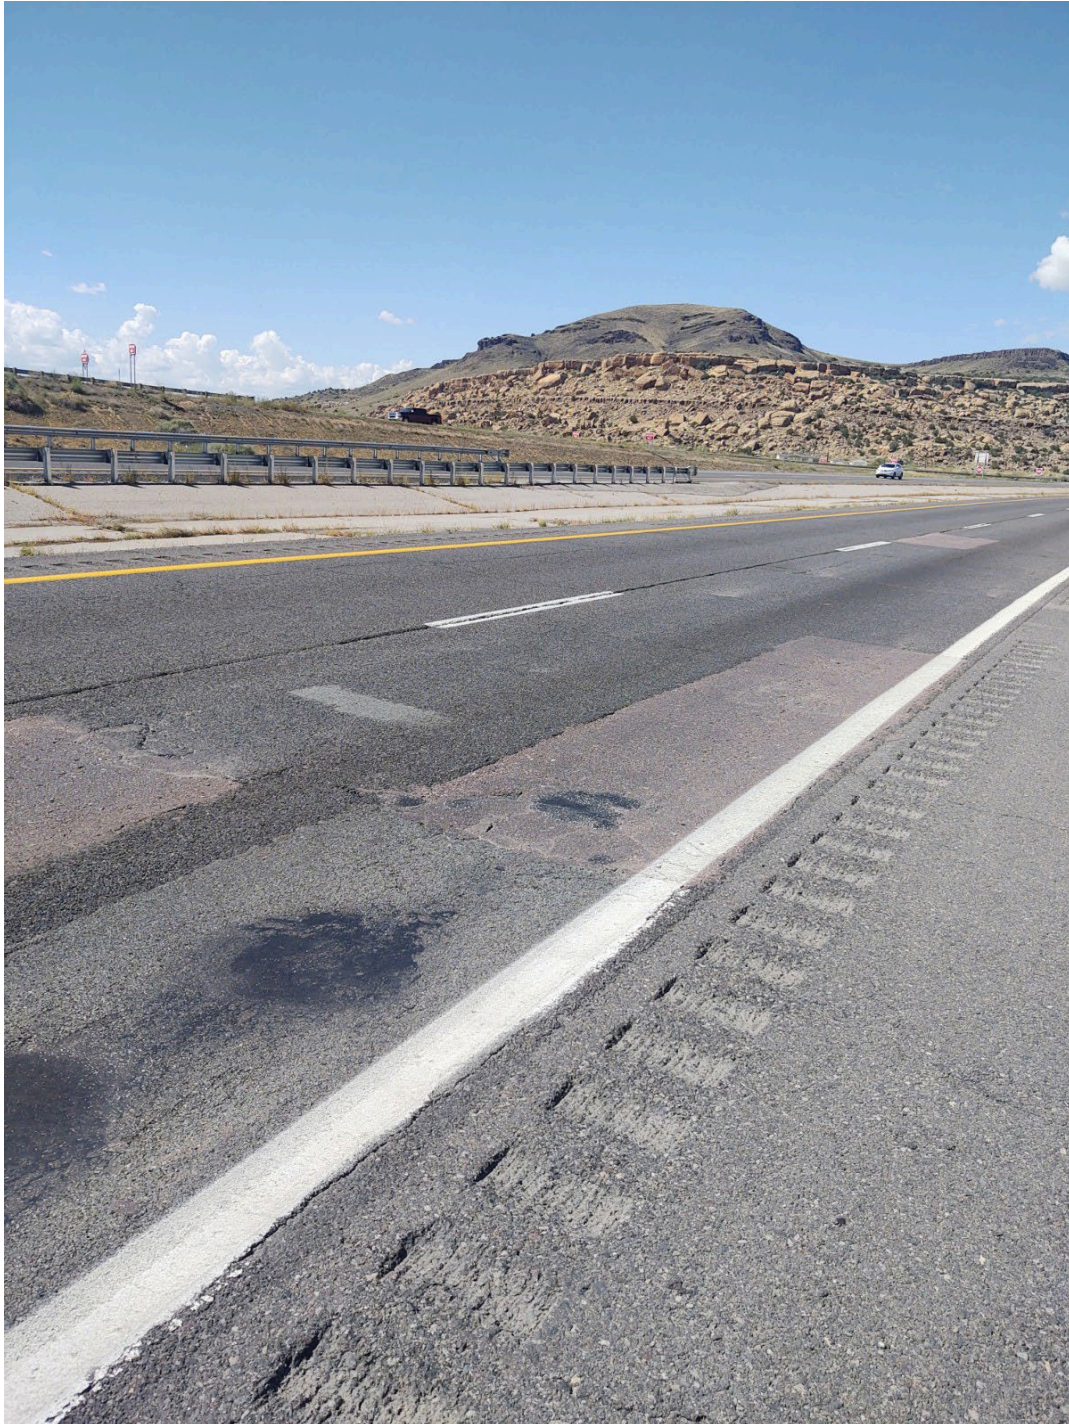
Photo 6: MP 104.5 - Looking NW along I-40

Low to moderate severity patching. Low to moderate severity lifting/stripping of OGFC/overlay, longitudinal, and transverse cracking. Low to moderate severity weathering and oxidation along shoulder

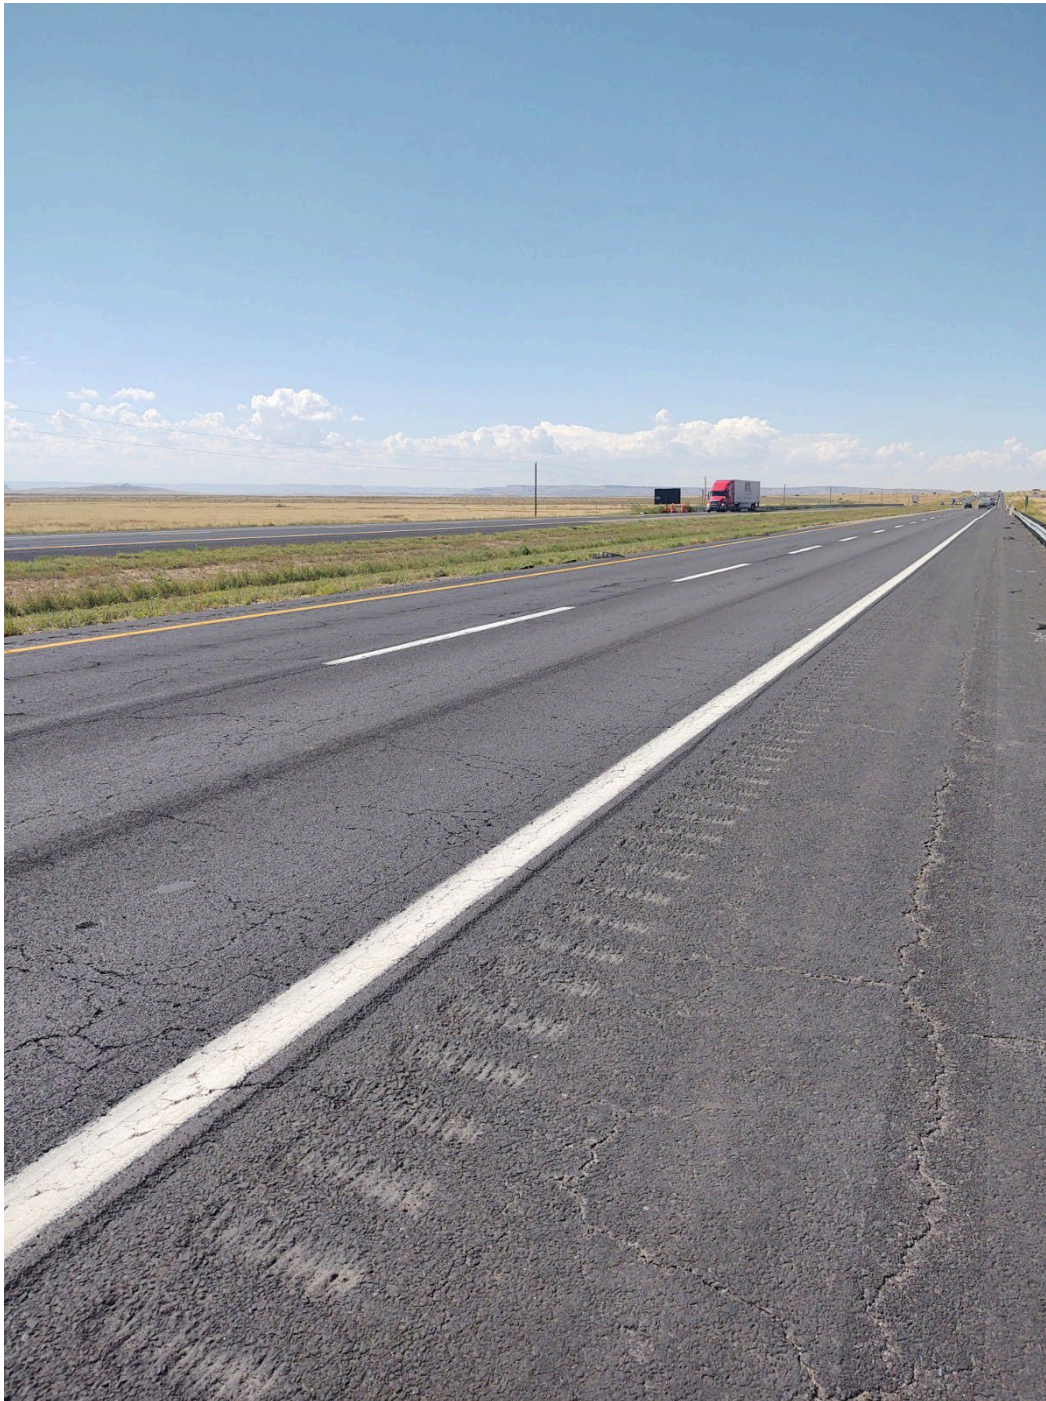
Photo 7: MP 126 - Looking SW along I-40

Low severity lifting/stripping of OGFC/overlay. Low to moderate severity longitudinal, block, and transverse cracking. Low to moderate severity longitudinal cracking, transverse cracking, weathering, oxidation along shoulder

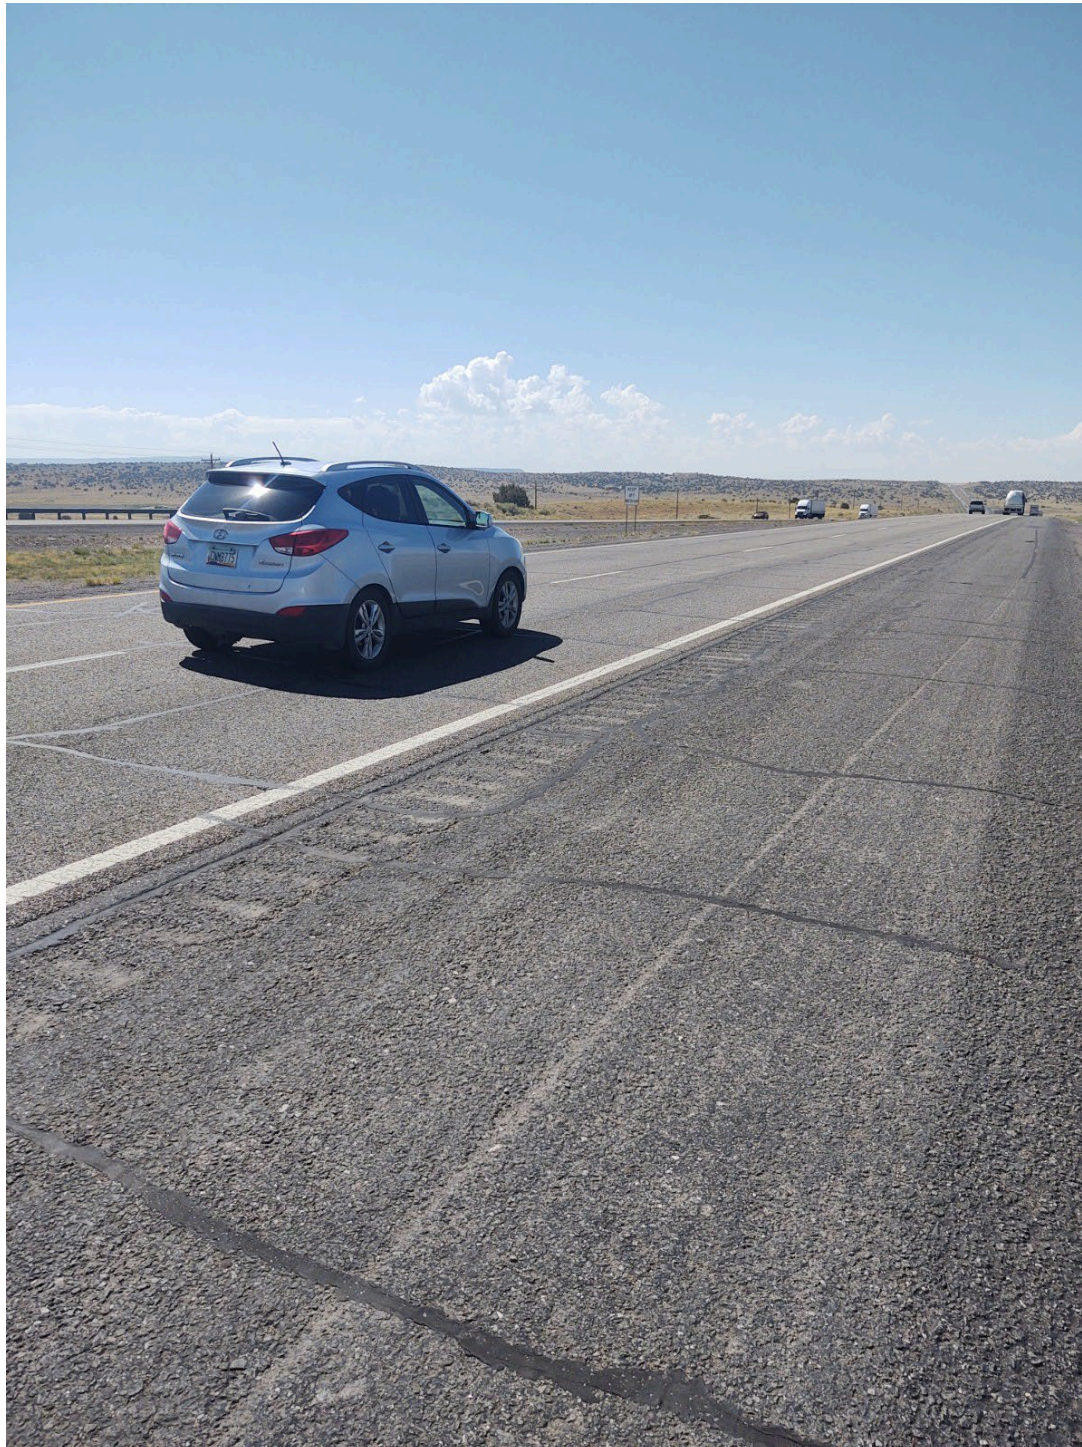
Photo 8: MP 138 - Looking SW along I-40

Low severity longitudinal and transverse cracking. Low to moderate severity weathering, raveling, and oxidation along shoulder. Crack filling performed.

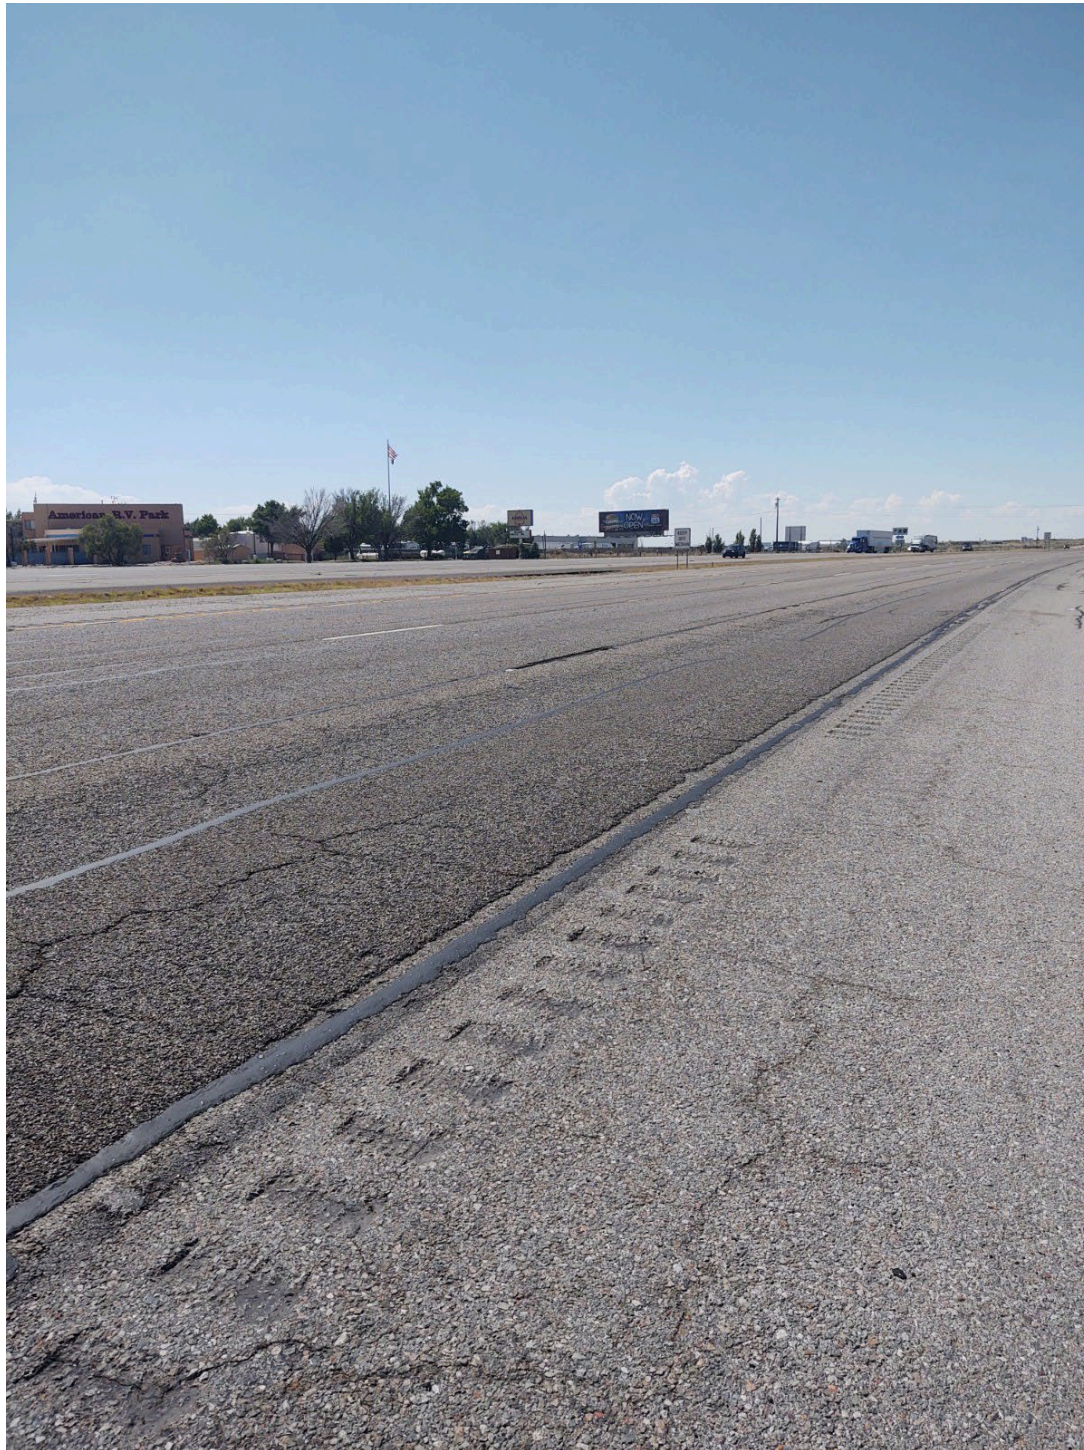
Photo 9: MP 149 - Looking SW along I-40

Low severity longitudinal, block, and transverse cracking. Low to moderate severity weathering, raveling, and oxidation along shoulder

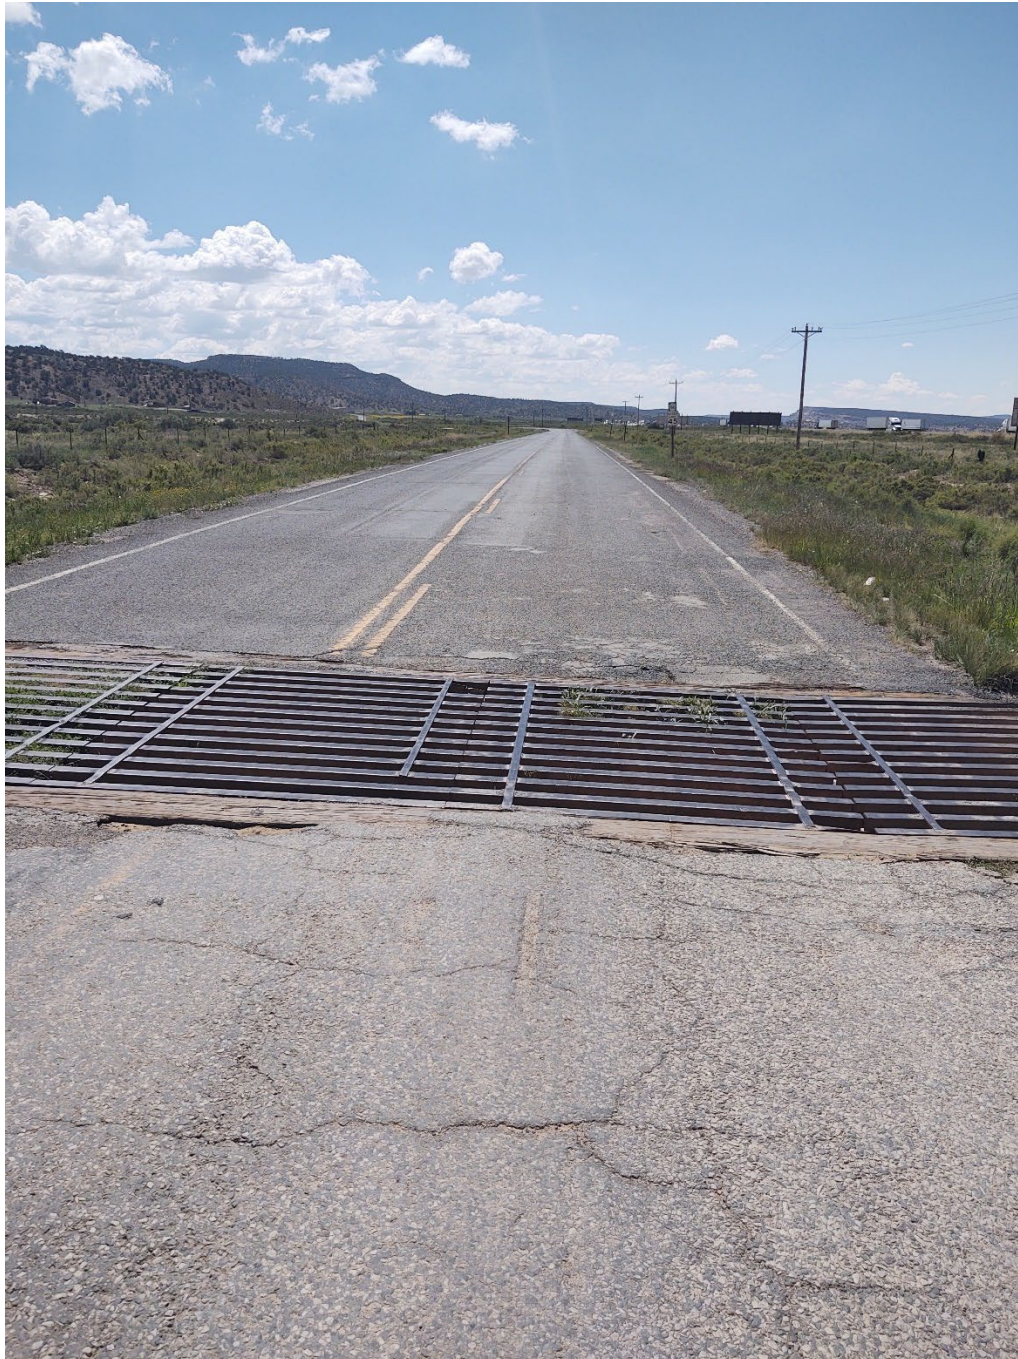
Photo 10: MP 7.5 - Looking W along Frontage Road

Low severity lifting/stripping of OGFC/overlay. Low to moderate severity longitudinal, block, and transverse cracking. Low severity weathering, oxidation, and raveling.

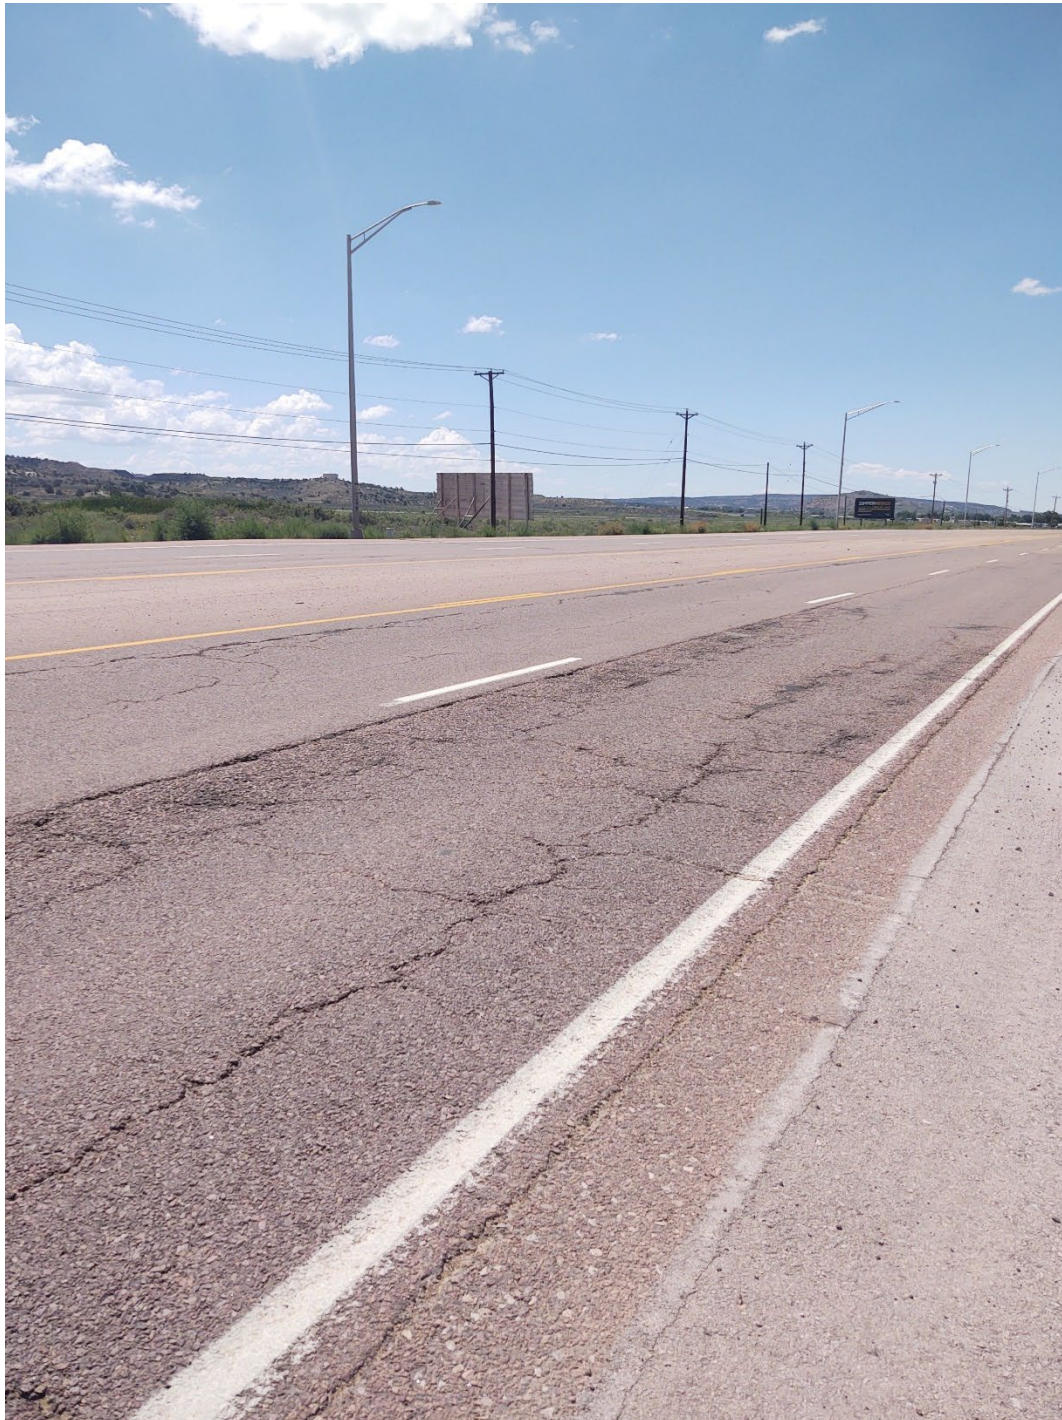
Photo 11: MP 18 - Looking SW along Frontage Road/Old Route 66

Low to moderate severity lifting/stripping of OGFC/overlay. Low to moderate severity longitudinal, block, and transverse cracking. Low severity weathering, oxidation, and raveling.

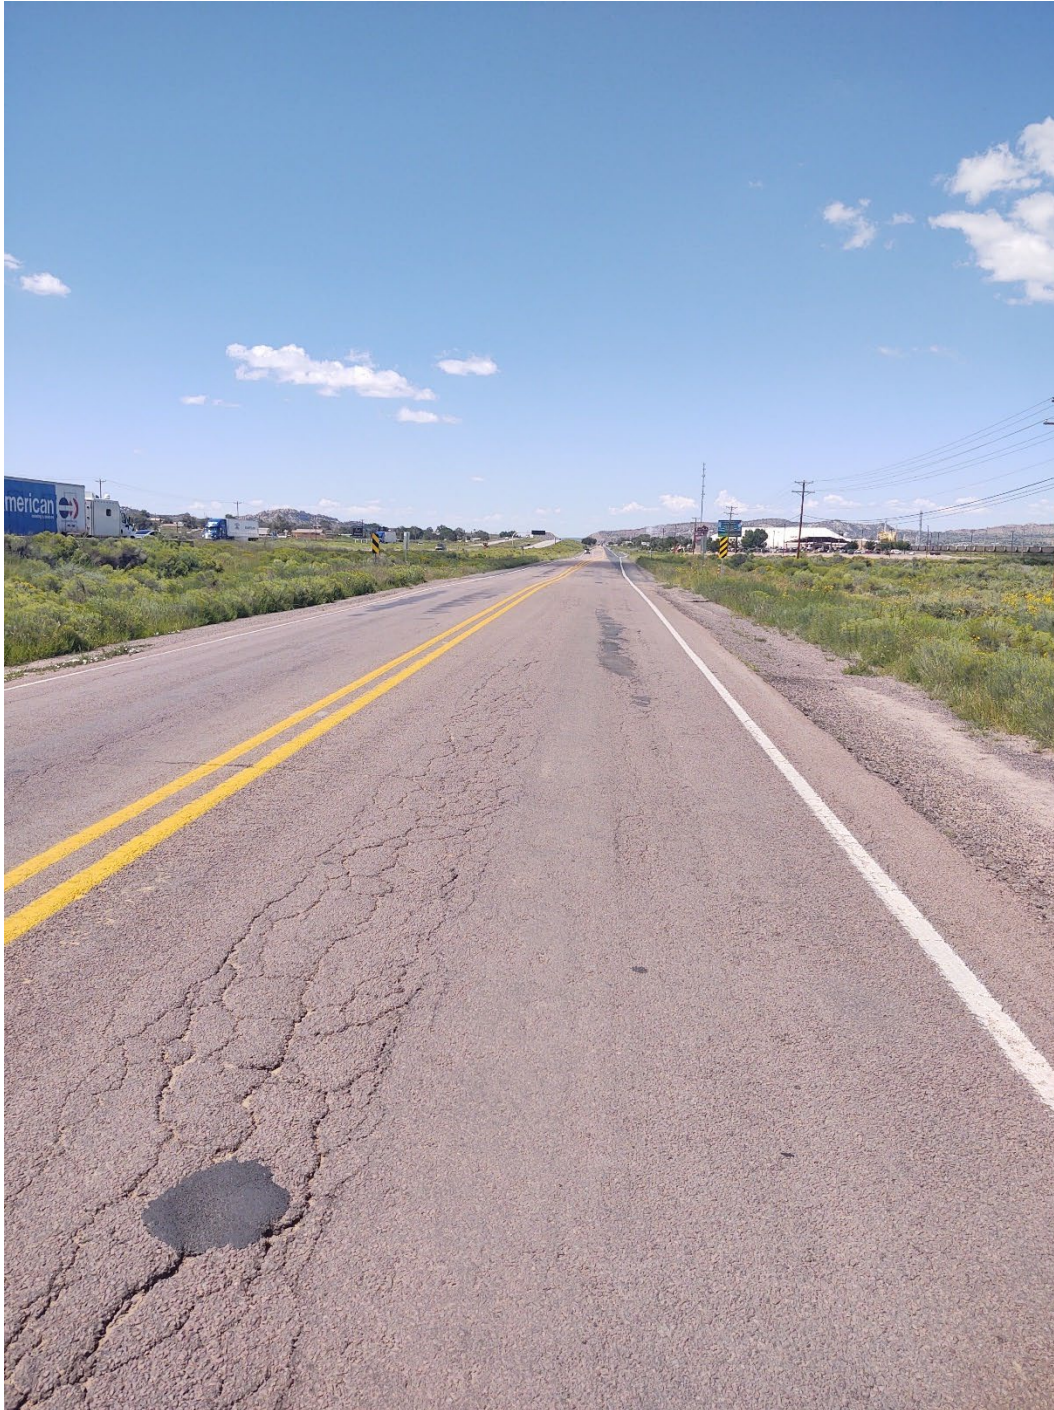
Photo 12: MP 28 - Looking W along Frontage Road

Low to moderate severity lifting/stripping of OGFC/overlay. Low to moderate severity longitudinal, block, and transverse cracking. Low to moderate severity patching. Low severity weathering, oxidation, and raveling.

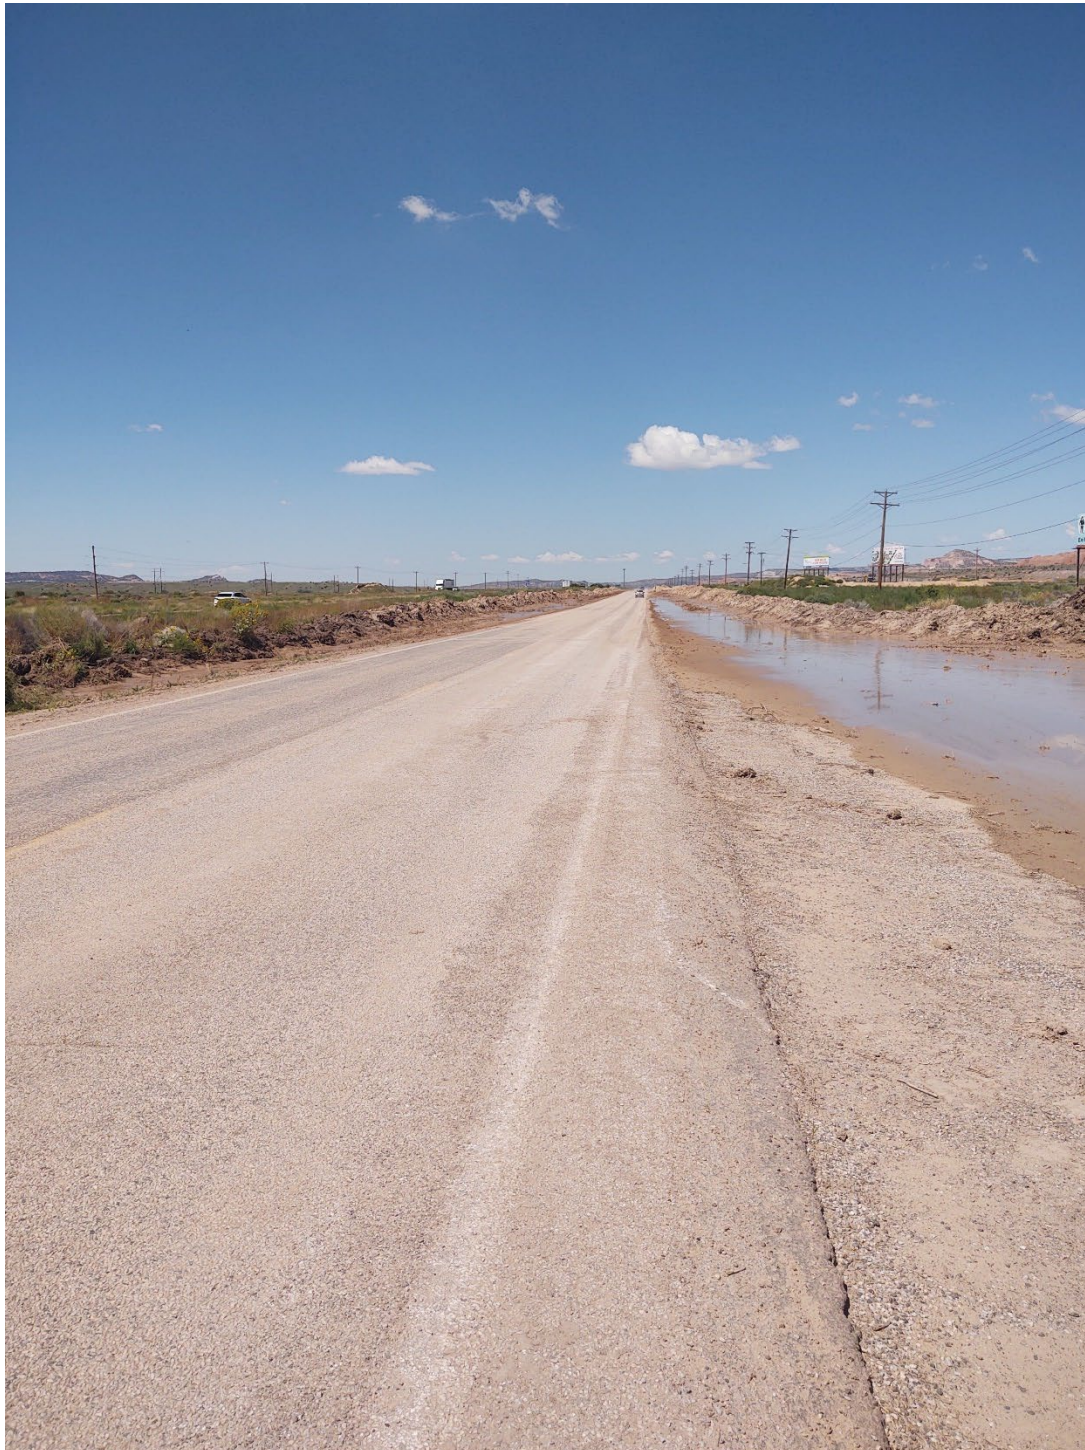
Photo 13: MP 33.5 - Looking W along Frontage Road

Low to moderate depressions/poor drainage. Low to moderate severity longitudinal, block, and transverse cracking. Low to moderate severity weathering, oxidation, and raveling.

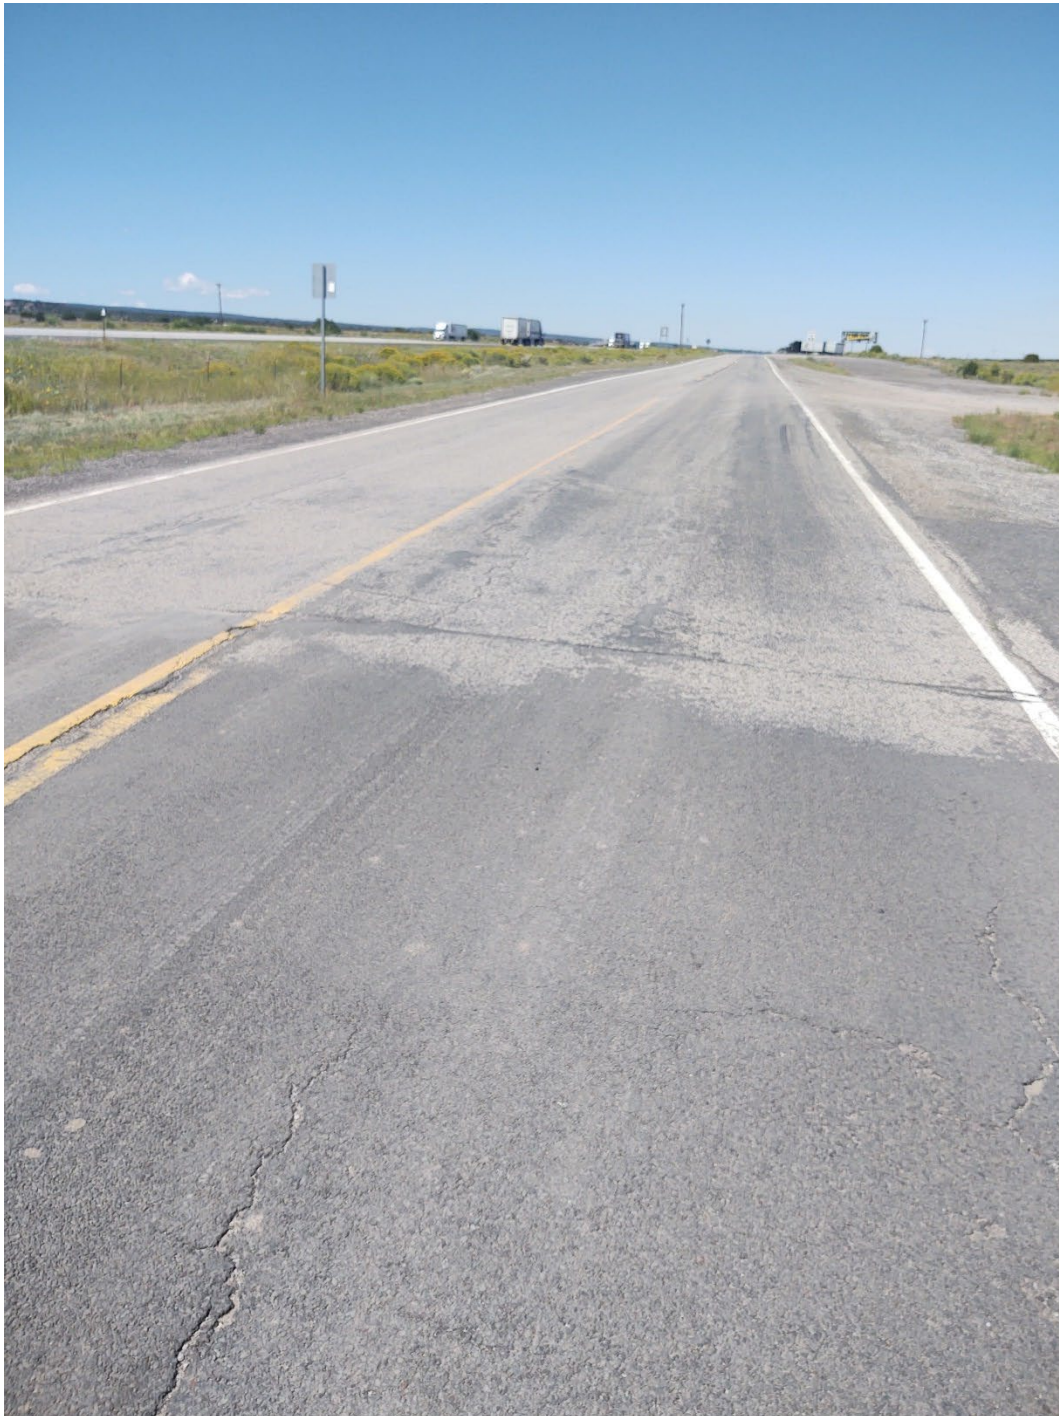
Photo 14: MP 52.5 - Looking W along Frontage Road

Low severity lifting/stripping of OGFC/overlay. Low to moderate severity longitudinal and transverse cracking. Low to moderate severity weathering, oxidation, and raveling.

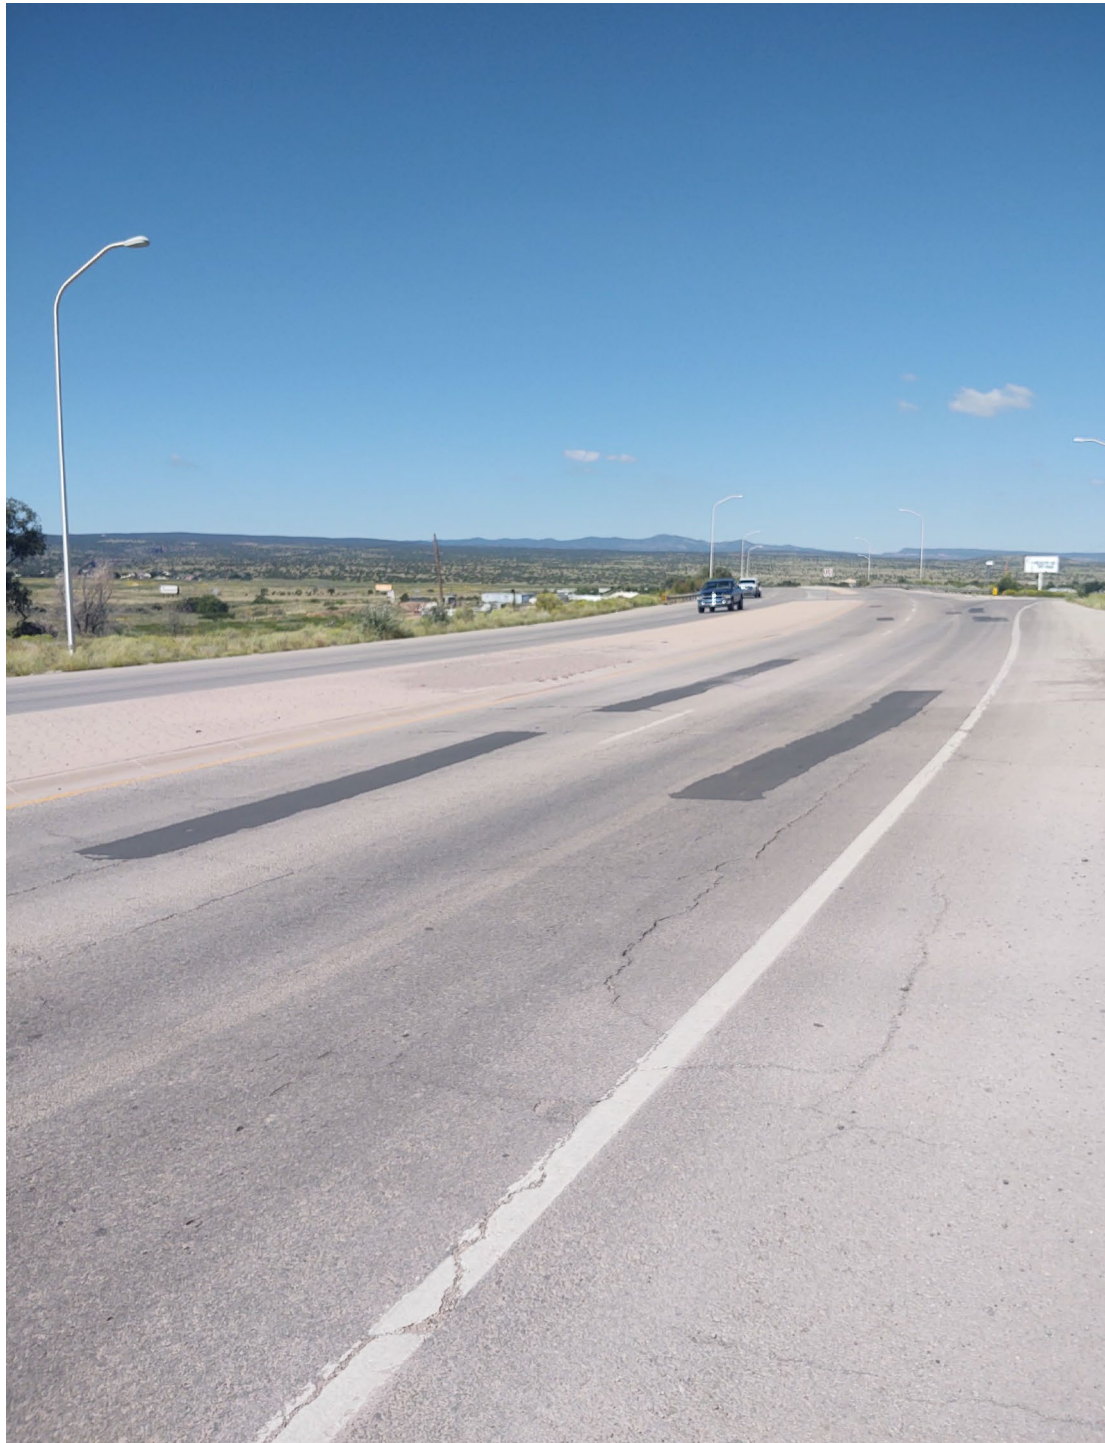
Photo 15: MP 80 - Looking W along Frontage Road

Low severity longitudinal and transverse cracking. Low severity patching. Low severity weathering, oxidation, and raveling.
