Geotechnical Scoping Report

Phase I-A/B Corridor Study

I-40 Arizona State Line to Atrisco Vista Boulevard Interchange

May 2, 2024

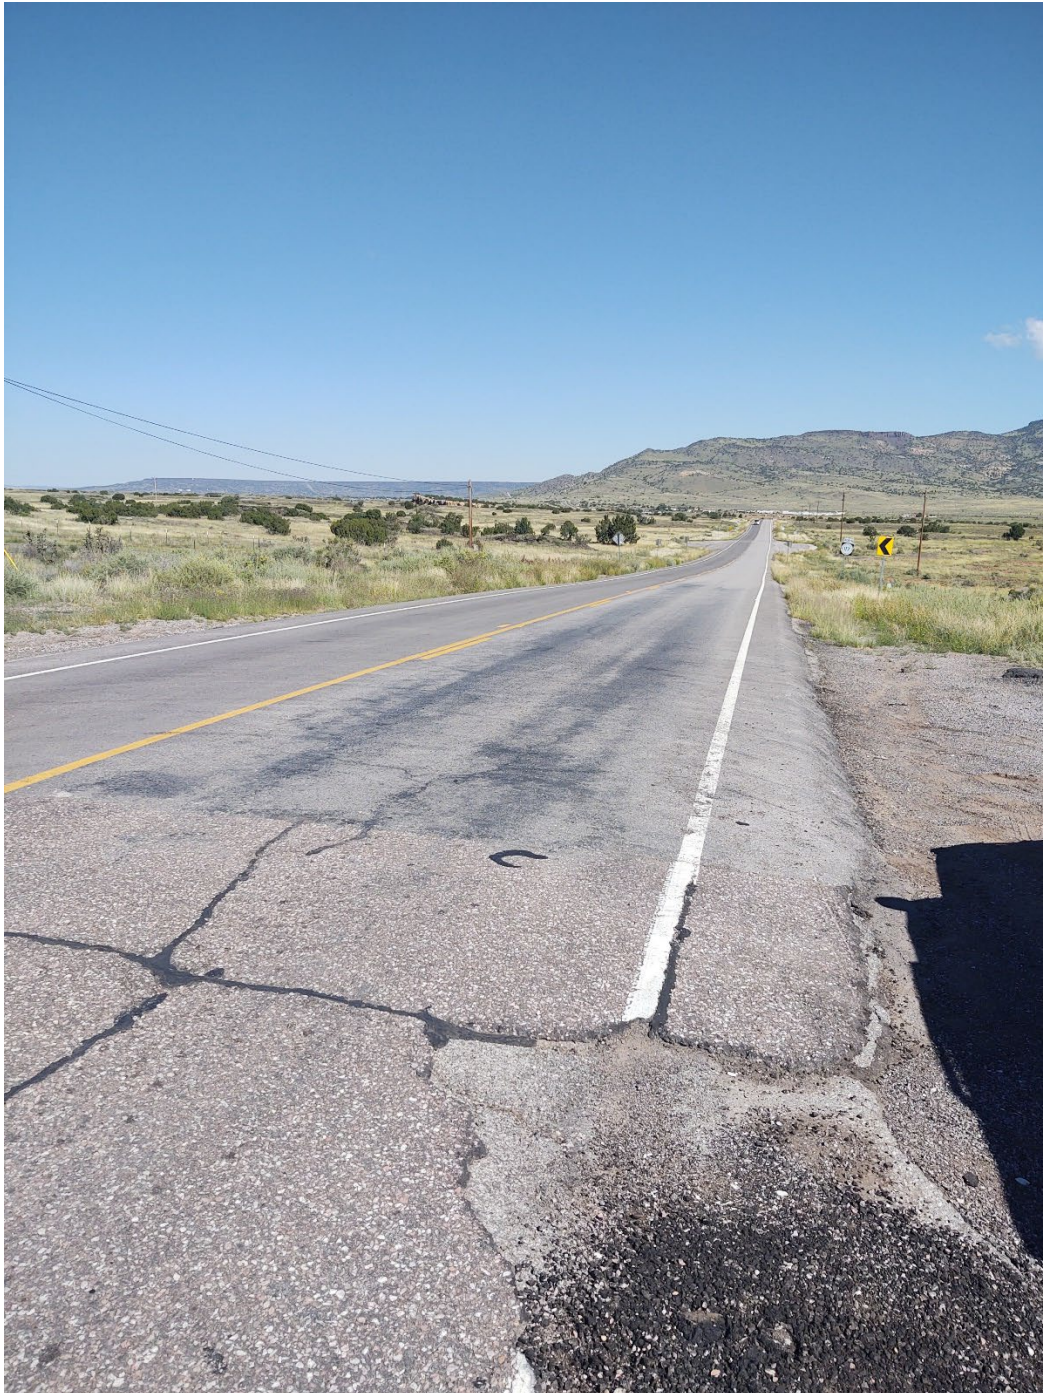
Photo 16: MP 90 - Looking W along Frontage Road

High severity lifting/stripping of OGFC/overlay. Low severity bleeding. Low to moderate severity longitudinal and transverse cracking. Low severity weathering, oxidation, and raveling. Crack filling performed.
