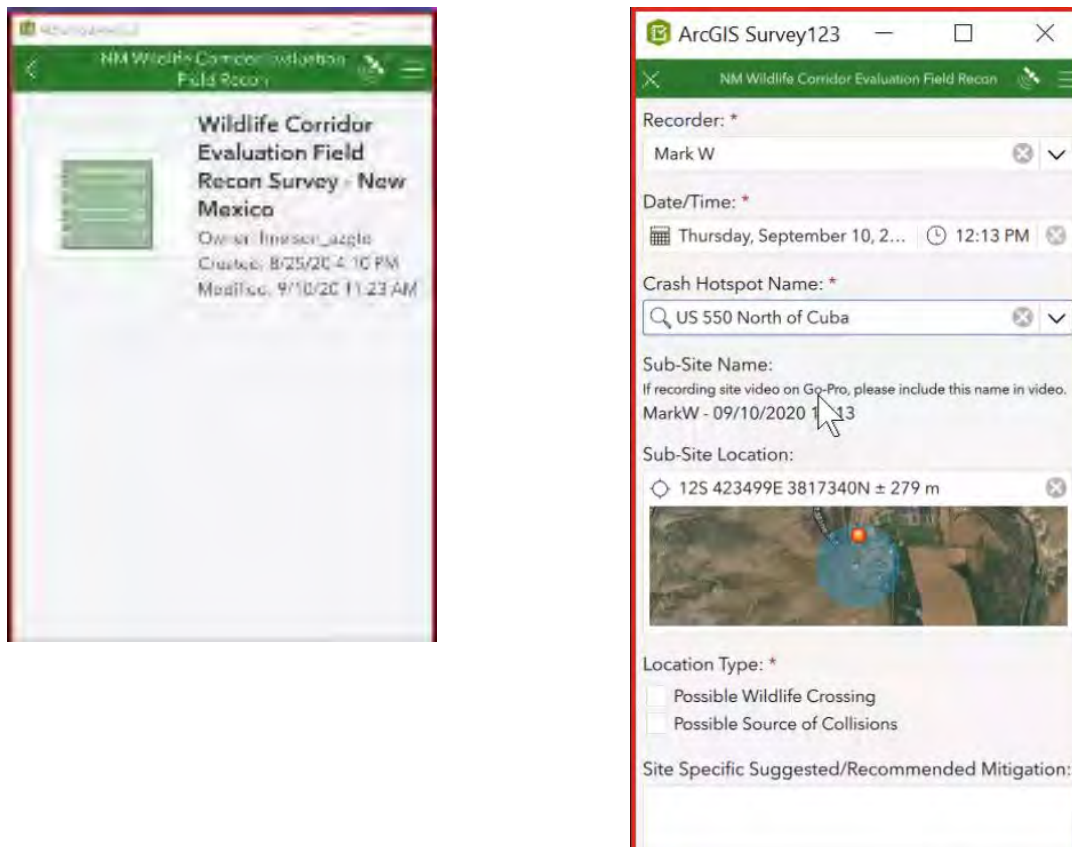
Figure ES-3. Introduction page of the survey form (left) and input page for a mini-site within the Cuba hotspot (right).

An ArcGIS Survey 123 App survey form (Figure ES-3) was developed for field verification of potential mitigation opportunities, fence limits, and sources of collisions within each priority area identified.

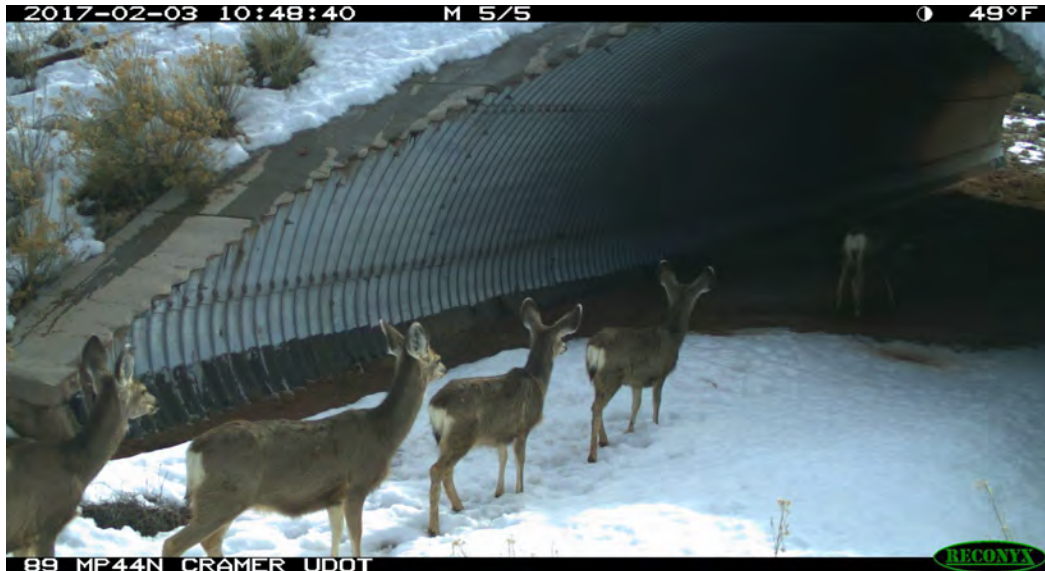
Figure 1-7. Mule deer migrating through a dedicated wildlife crossing structure along the US 89 Kanab-Paunsaugunt Wildlife Mitigation Project (photo credit: Patricia Cramer, UDOT, Utah Division of Wildlife Resources, and AZGFD).

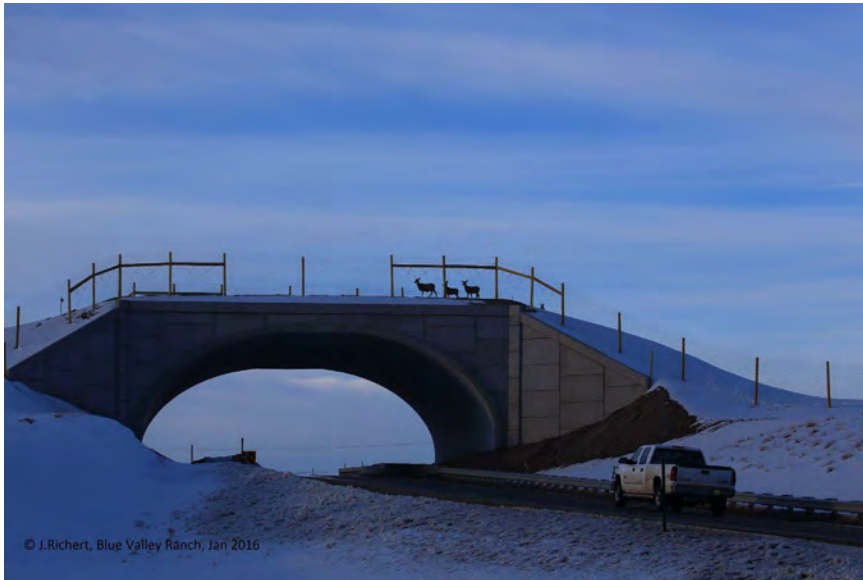
Figure 1-8. Mule deer moving over one of the SH 9 wildlife overpasses in Colorado (photo credit: Josh Richert, Blue Valley Ranch).

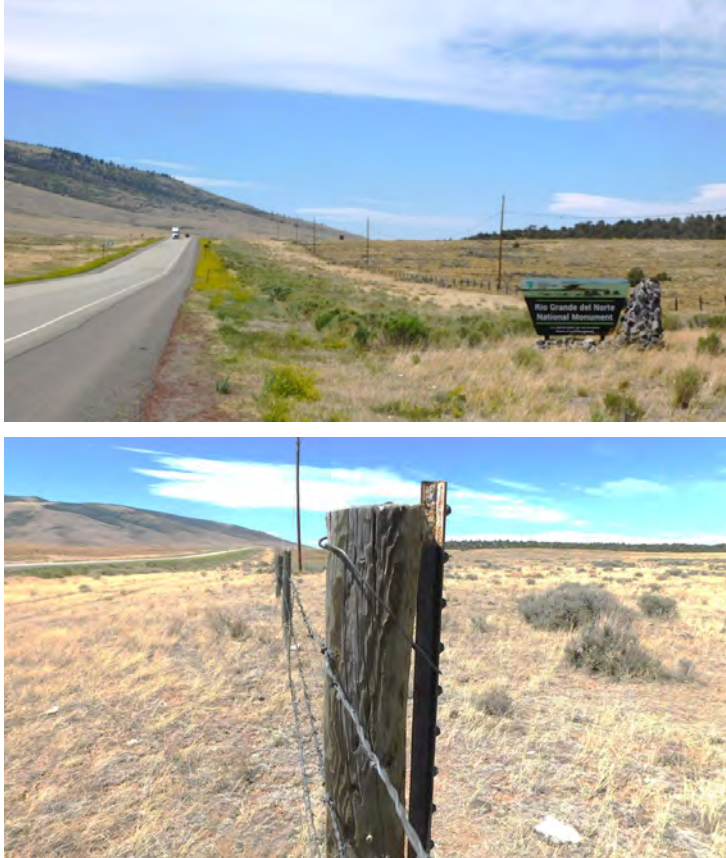
Figure 6-37. Rio Grande Del Norte National Monument and US 285 looking north (top) and Del Norte laydown fence in upright position (bottom) (photo credit: P. Cramer).

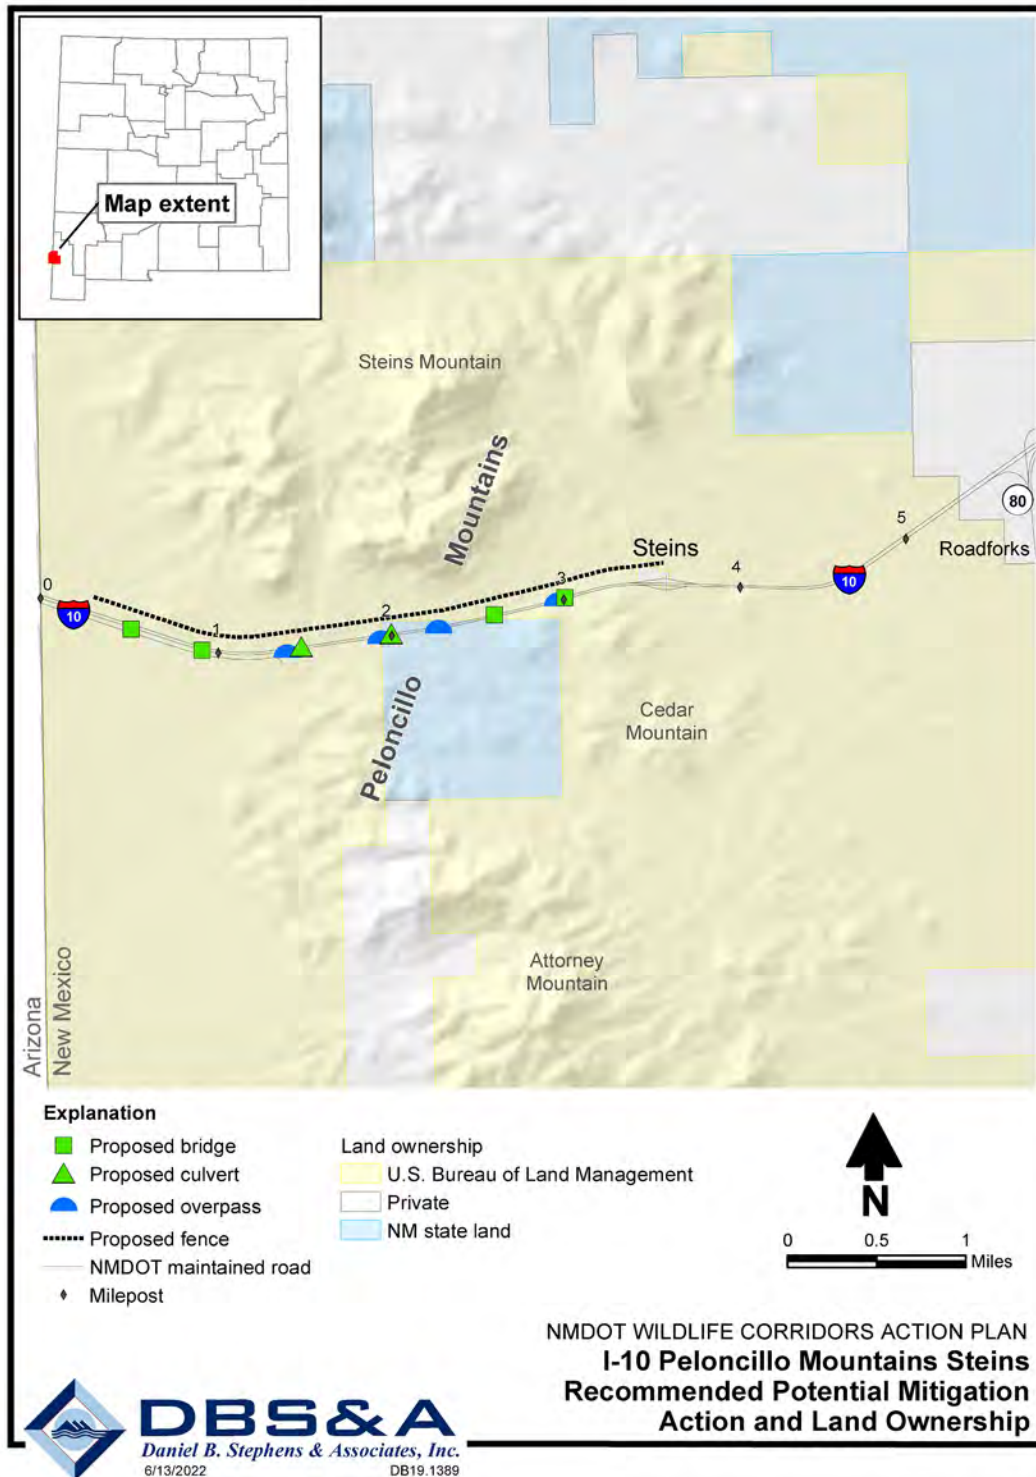
Figure 6-57. Land ownership and recommended project mitigation actions in the Peloncillo Mountains wildlife corridor.

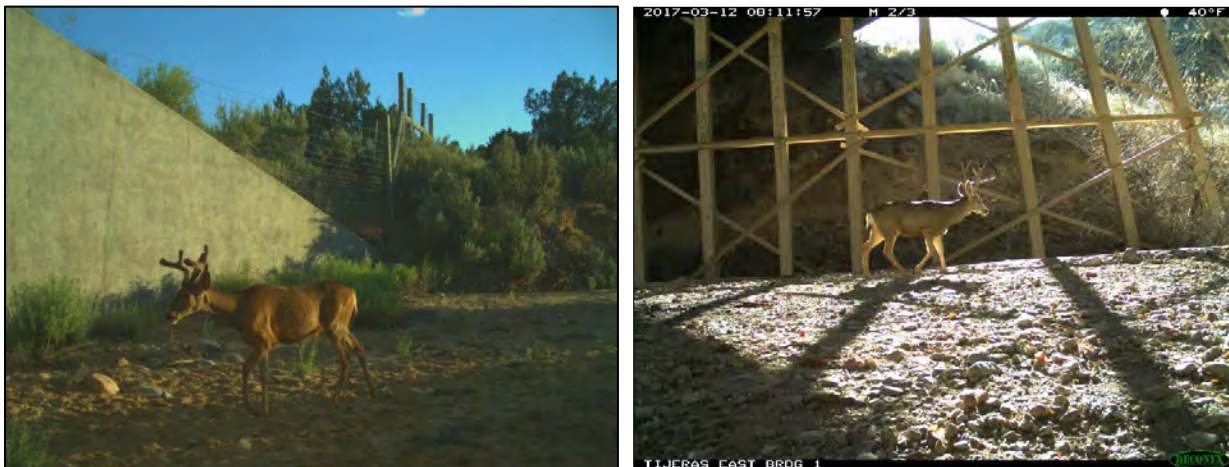
Figure 7-8. Example of adequate monitoring at a small culvert (left) and at a larger road-crossing structure (right) in New Mexico using motion-triggered, remote cameras. The cameras capture both approaches and crossings of deer and other wildlife at the culvert, allowing for the calculation of passage rates, thus contributing to knowledge about the effectiveness of mitigation measures. At the larger structure, most approaches are expected to result in the successful passage of wildlife, at the same time that documenting all approaches is logistically more difficult; the use of cameras is more geared toward documenting the number of passages and the full range of species using the structure (right).

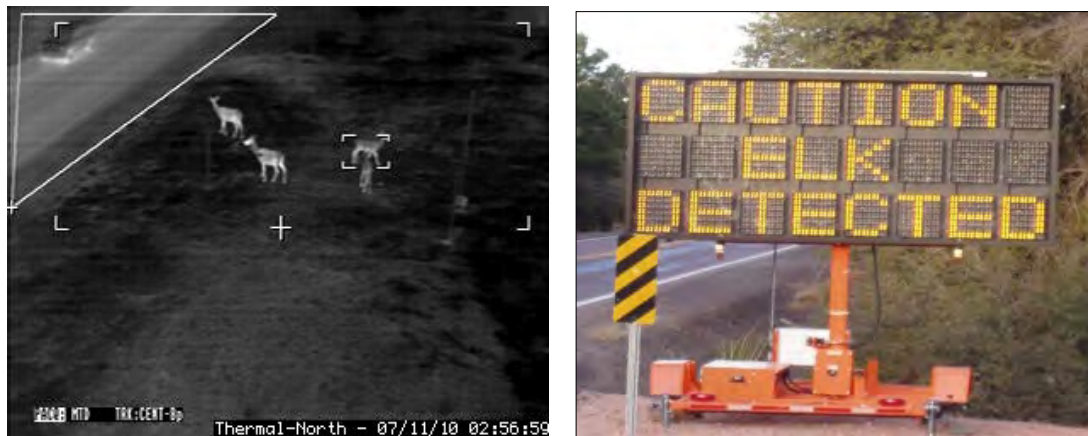
Figure 7-10. Example of thermal target acquisition software used to activate motorist alert signs (left) and sign activated when a target is identified as wildlife large enough to pose a safety concern to motorists.

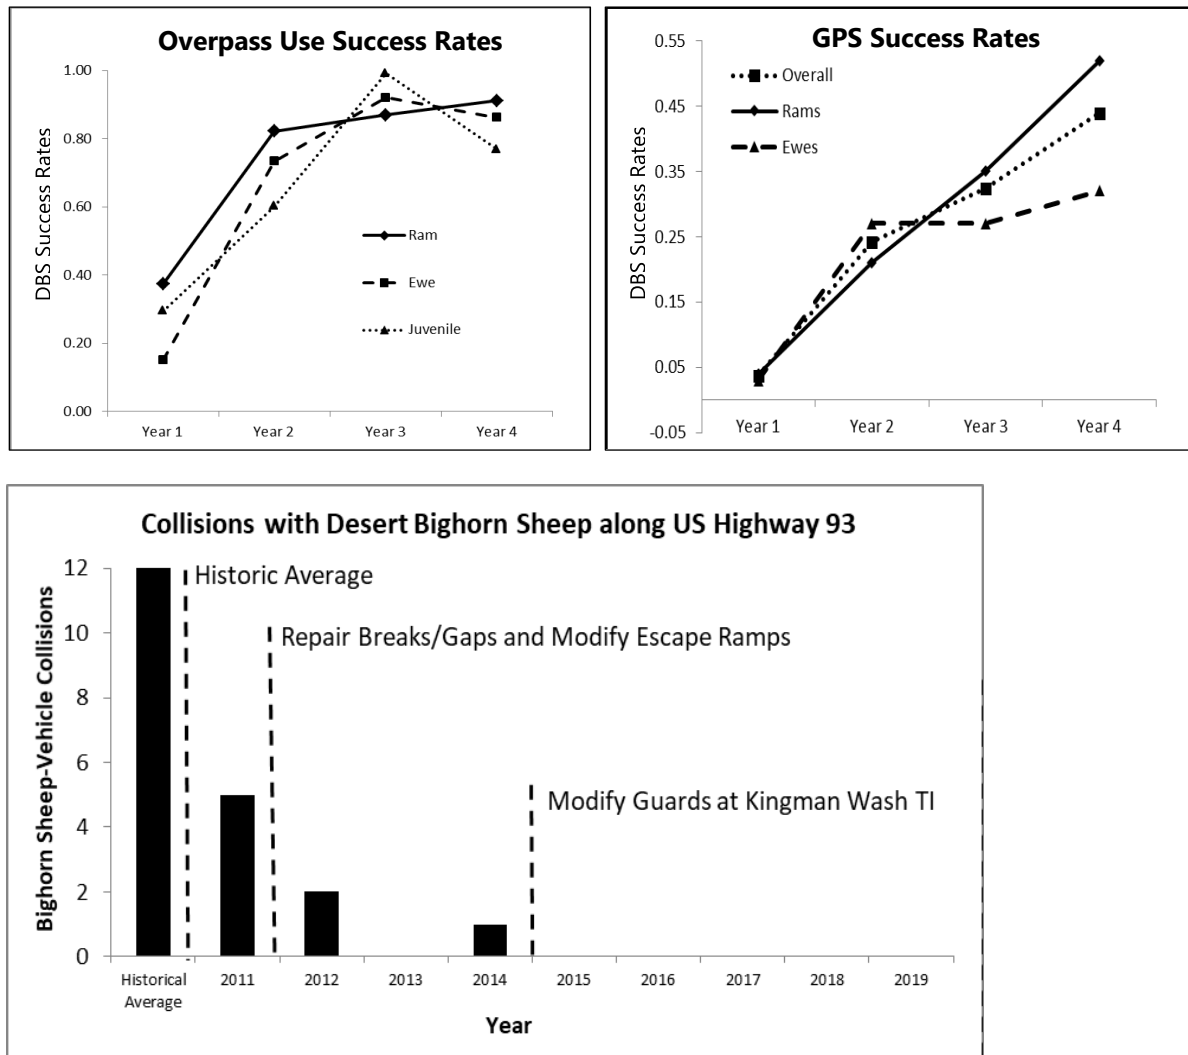
Figure 7-12. Results of a US 93 bighorn sheep study illustrating the importance of long-term monitoring in determining the ultimate success of a project. Upper left graph shows success rate of GPS-collared sheep crossing US 93 over time. Upper right graph shows success rate of sheep using the overpasses over time. Lower graph shows reduction in collisions over time through adaptive management and continued monitoring.

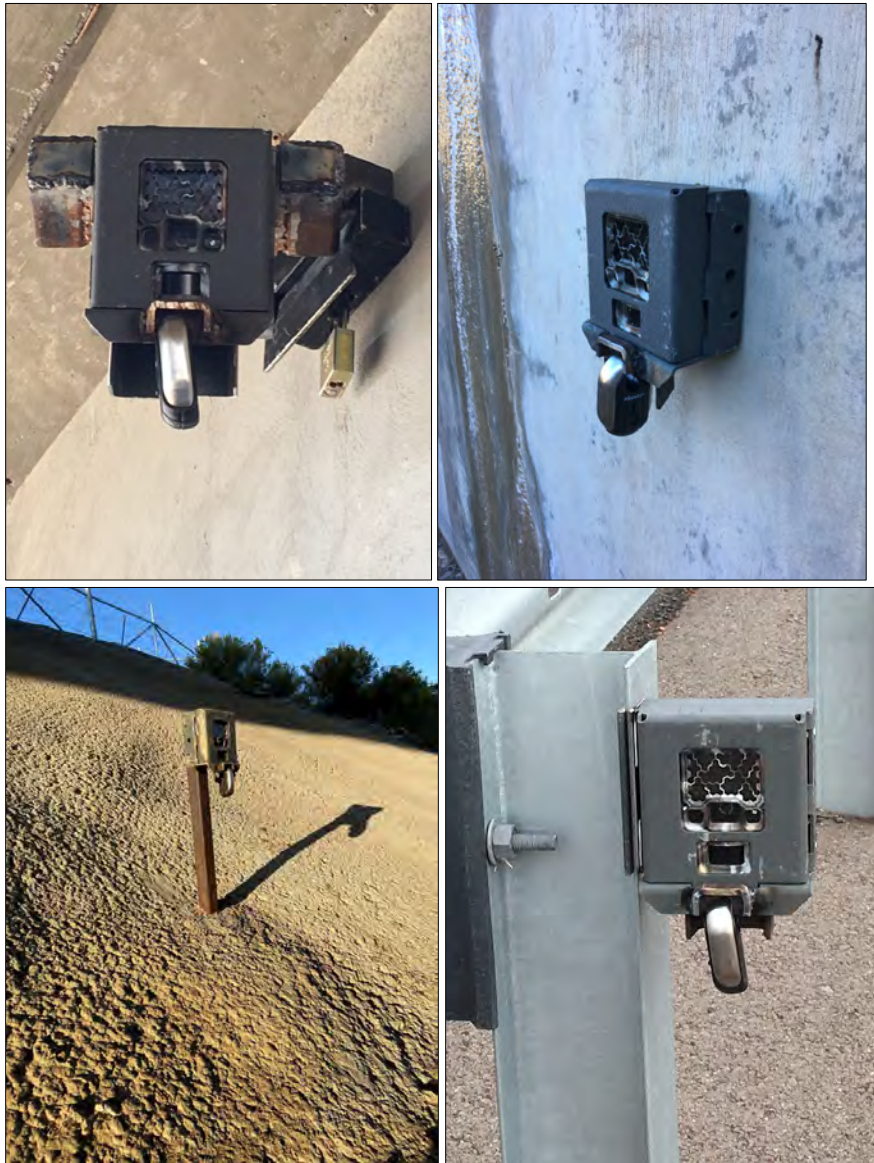
Figure 7-13. Consistent data collection from cameras is important to determine mitigation success, and taking measures to secure cameras is essential. Options like these being used in New Mexico can help reduce theft, and include articulated mounts that deter cutting with power or hand tools (upper left), flush mounts with robust anchors to hinder prying (upper right), cameras welded to poles and set in concrete (lower left), and hiding cameras in discrete locations such as behind a guardrail (lower right).

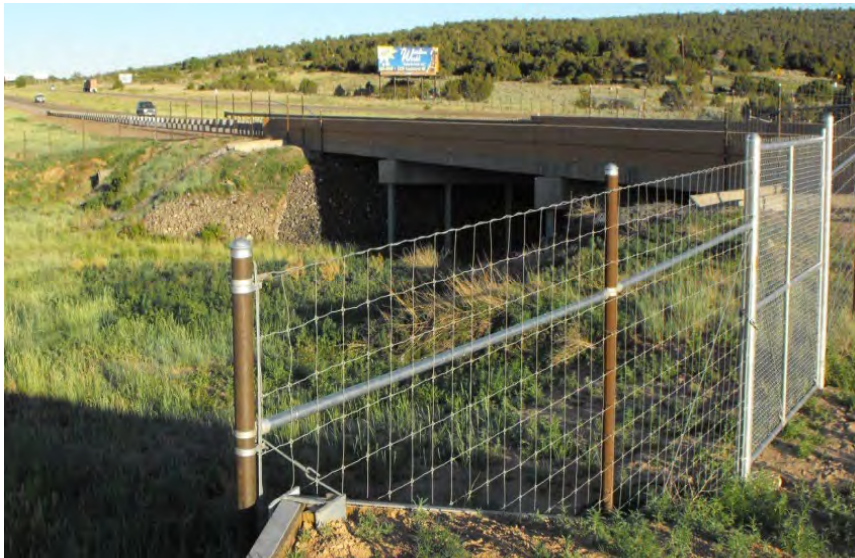
Figure A-7. Bridge under I-40 used by wildlife near Edgewood (photo credit: M. Watson).

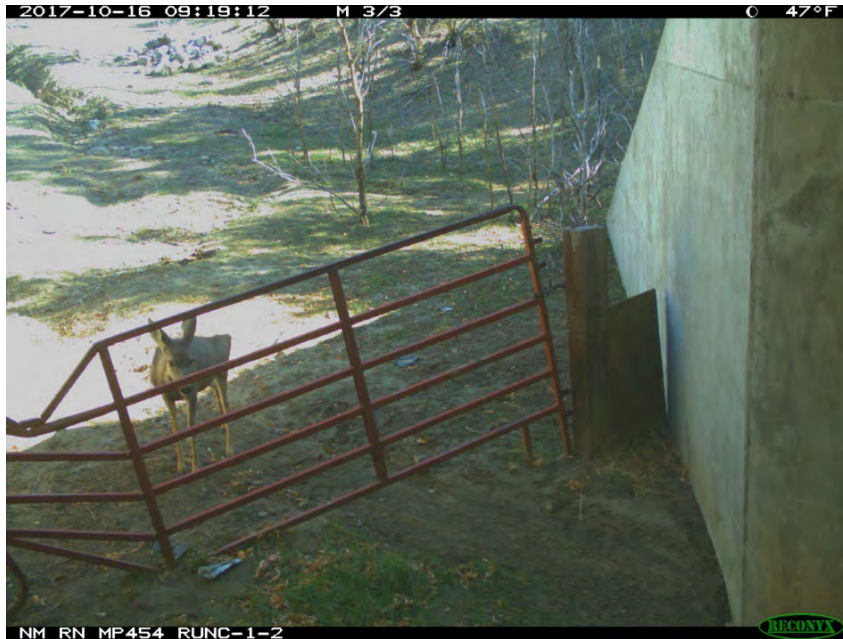
Figure A-16. Gate placed by landowner on box culvert to keep livestock from using culvert (photo credit: AZGFD, NMDOT).

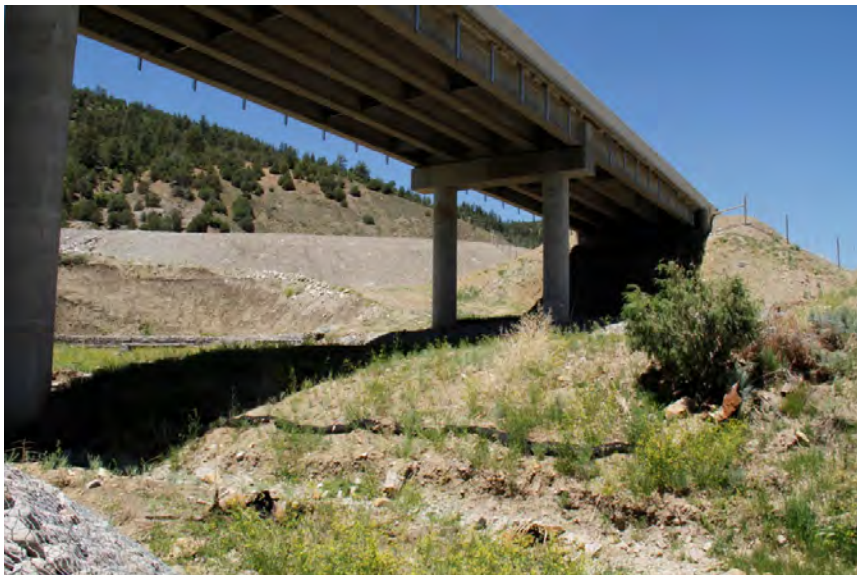
Figure A-19. US 64 near Lumberton Bridge over Amargo Creek at MP 144.8.

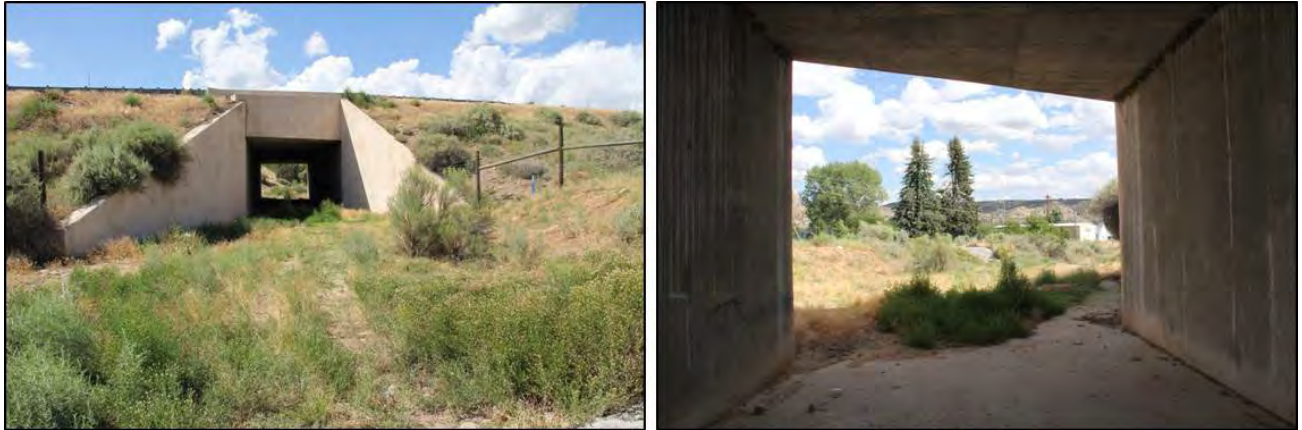
Figure A-23. US 550 wildlife crossing concrete box culverts (photo credit: AZGFD).

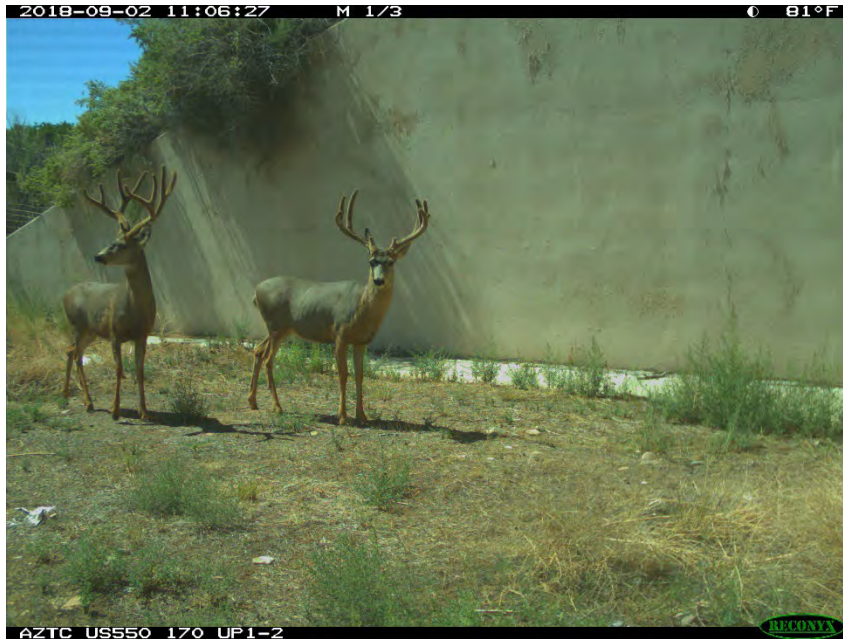
Figure A-25. Mule deer bucks using the wildlife crossing box culvert to move beneath US 550 (photo credit: AZGFD, NMDOT).

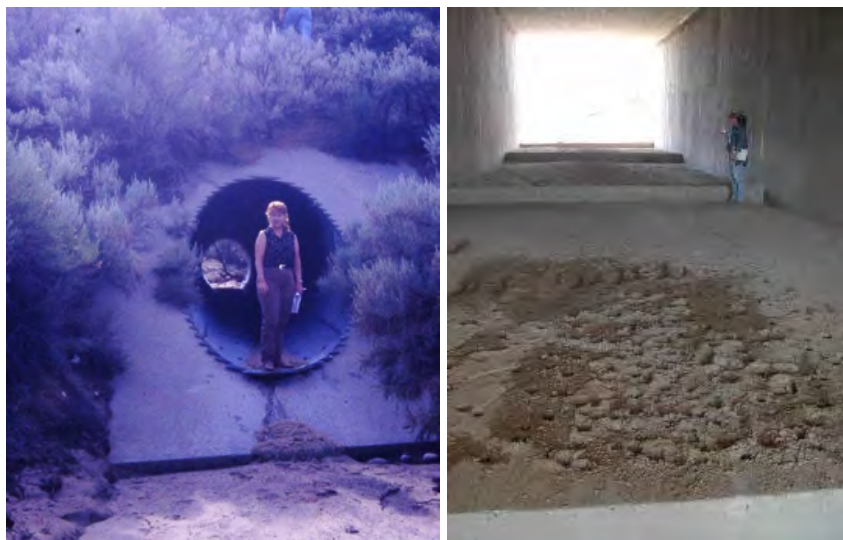
Figure D-12. US 550 original corrugated metal culvert (left), replaced with a wildlife crossing concrete box culvert (right) in the Aztec Project (photo credit: M. Watson).

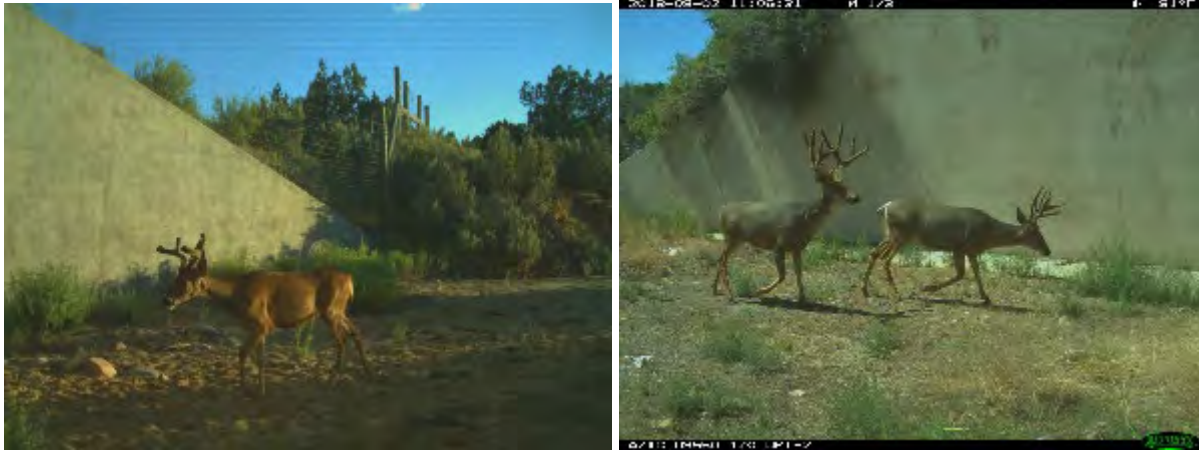
Figure D-13. Mule deer successfully moved through the US 550 wildlife crossing culverts (photo credit: AZGFD and NMDOT).

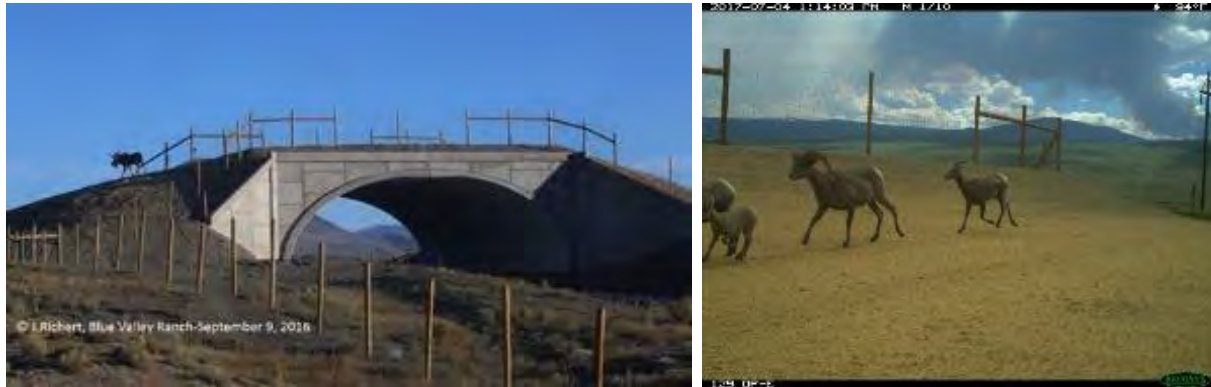
Figure D-14. Moose used the Colorado SH 9 overpass the first fall after completion (left). The overpass was created with pre-fabricated arches (photo credit: J. Richert, Blue Valley Ranch). Bighorn sheep use a Colorado SR 9 overpass (right) (photo credit: Eco-Resolutions, CDOT, and CPW).

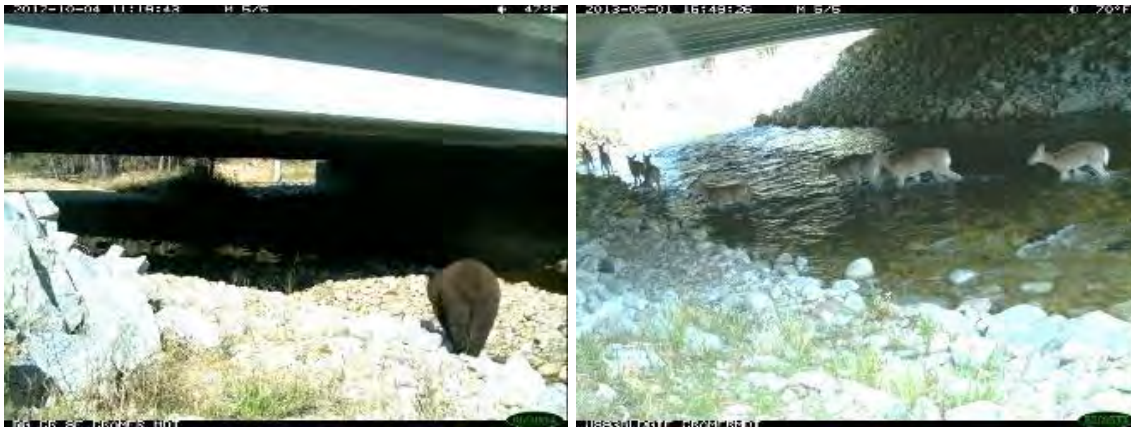
Figure D-22. In Montana, black bear and white-tailed deer used bridged wildlife crossing structures with and without water features (photo credit: P. Cramer and Montana DOT).

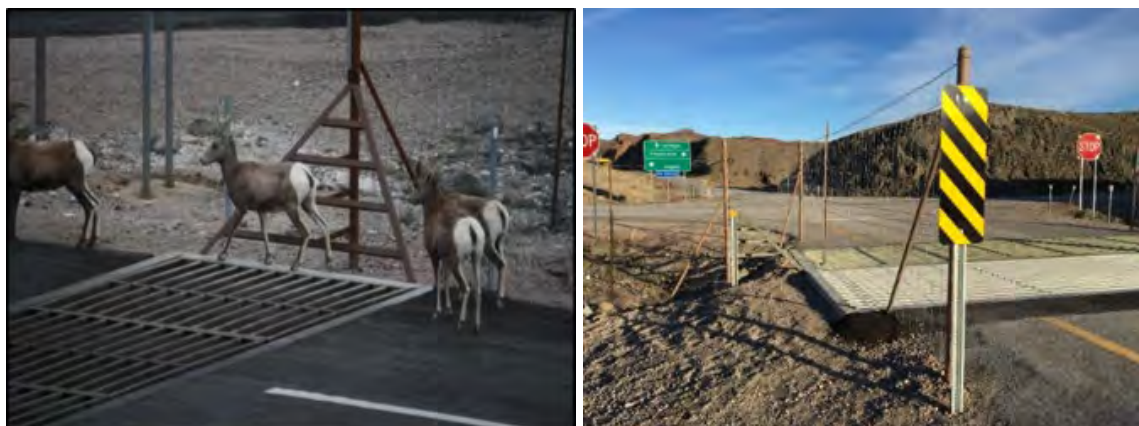
Figure D-44. Desert bighorn sheep breach a single cattle guard by using support lip in Arizona (left). The guard was adapted to a double cattle guard and the vault lip was covered with fence (right). Monitoring Found no bighorn sheep breaches after retrofit (photo credit: AZGFD, AZDOT).

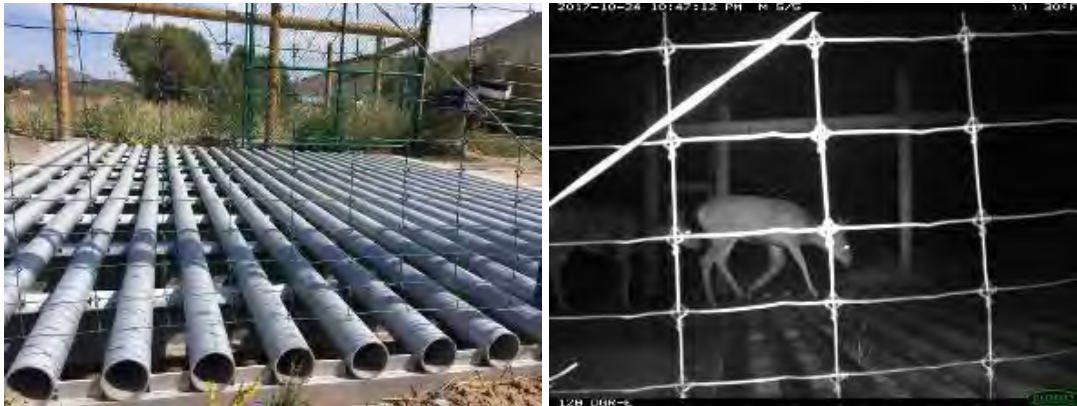
Figure D-45. Colorado SH 9 round bar double cattle guard (left) (photo credit: P. Cramer). How mule deer can use the support beams to breach the guard (right) (photo credit: CDOT, CPW, and ECO-Resolutions).

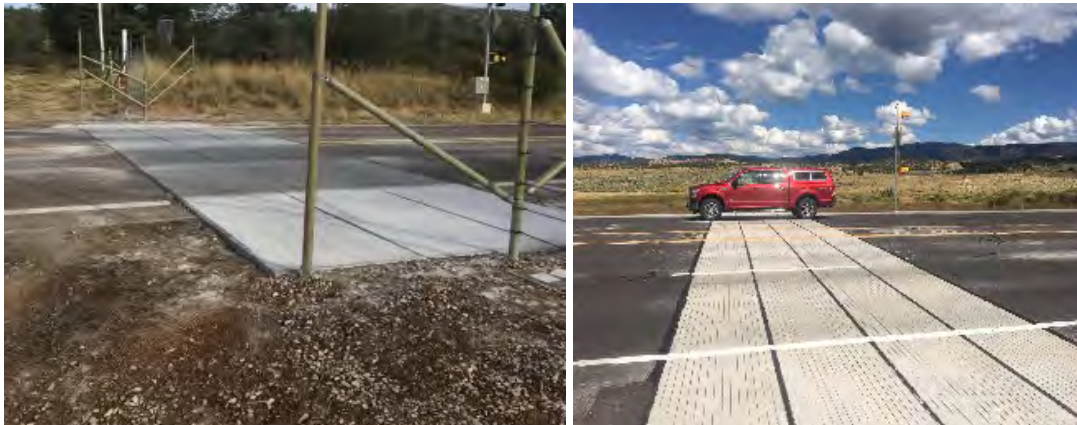
Figure D-47. Electrified barriers installed along SR 260 in Arizona (left) and along US 550 in New Mexico (right) to keep elk and deer out of the right-of-way (photo credit: AZGFD).
